| | API 570 Inspection on a 6" pipeline | |
| <b>Project Name:</b><br>Fuel line inspection (Berths 1 and 2) | <b>Client Name.:</b><br>Guyana Shore Base Inc. (GYSBI) | <b>Equipment/Tag#:</b><br>Fuel line – Berths 1 and 2 |
| | | <b>Report N-r. :</b><br>APGY/2026/API-04 |

## API 570 Inspection on a 6" piping Fuel line (Berths 1 and 2)

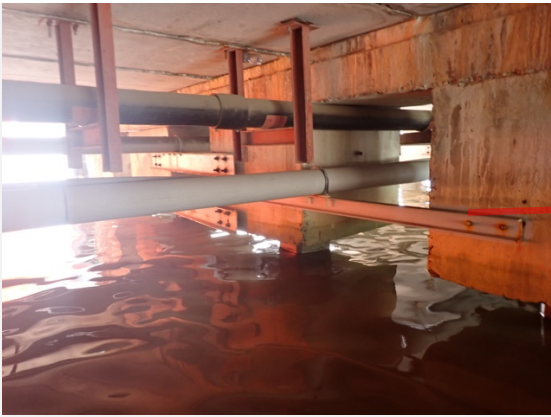
| <p>Photo: 1</p> <p>Comment: Typical view of the supports, underneath the wharf</p> | <p>Photo: 2</p> <p>Comment: Corrosion to the fasteners, typical to all supports</p> |

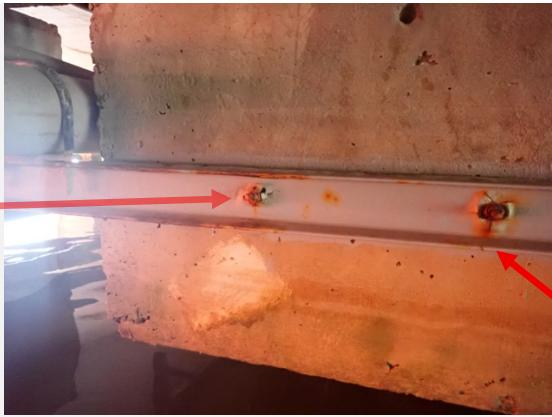
External corrosion to the fasteners, noted on all, steel to concrete mountings, see photos 1, 2 and 6. Replacement of the fasteners required.

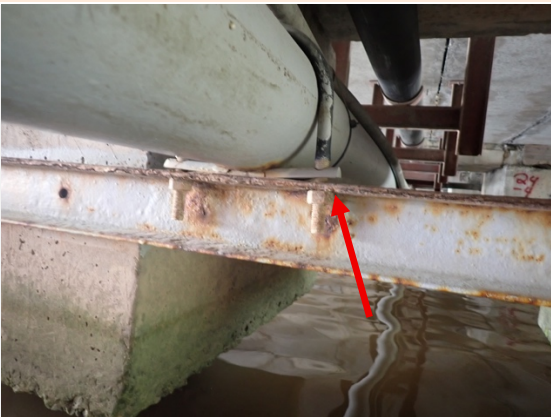
| <p>Photo: 3</p> <p>Comment: Pipe support PS 55. Damaged shim evident. Surface corrosion noted on the U-beam.</p> | <p>Photo: 4</p> <p>Comment: Pipe support PS 62. Surface corrosion noted on the U-beam.</p> |

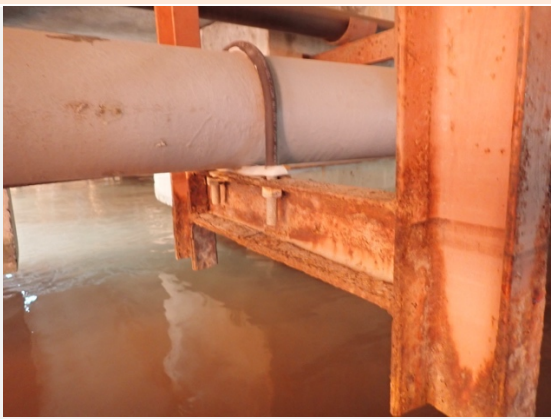
| <p>Photo: 5</p> <p>Comment: Pipe support PS63. Surface corrosion noted on the entire support structure.</p> | <p>Photo: 6</p> <p>Comment: Pipe support PS64 - Corrosion to the fasteners, typical to all supports</p> |

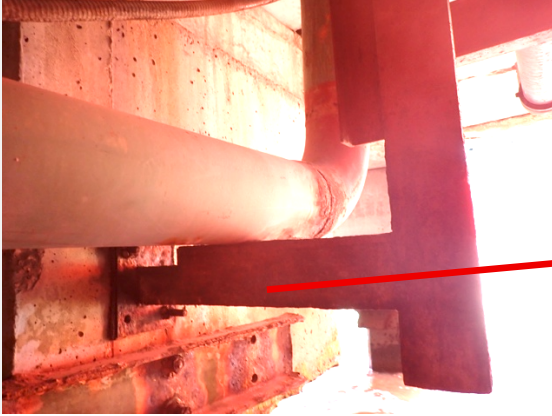
Heavy corrosion and heavy scale noted on the support PS74, entire support structure affected, see photos 7 and 8. No shim installed between pipe and the support. Fabric Maintenance urgently required.

Photo: 7  
Comment: Heavily corroded support, PS74 with scale present on the entire support structure. No shim installed. Located just below the penetration to the manifold area, at Berth 2.

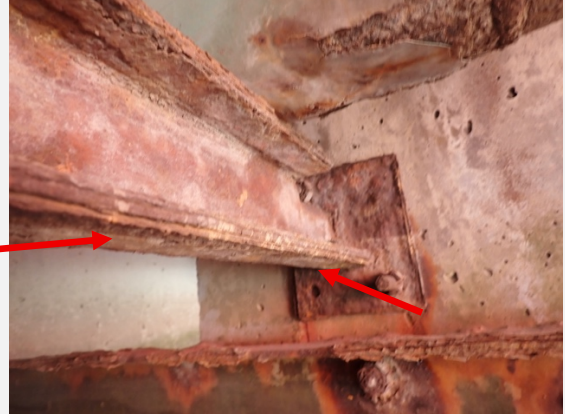
Photo: 8  
Comment: Heavily corroded support, PS74 with scale present on the entire support structure. Located just below the penetration to the manifold area, at Berth 2.

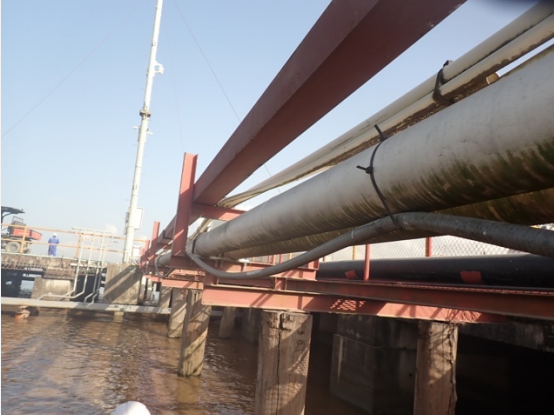
Photo: 1  
Comment: General view of the Fuel line running along the bridge, into the under the wharf – good condition

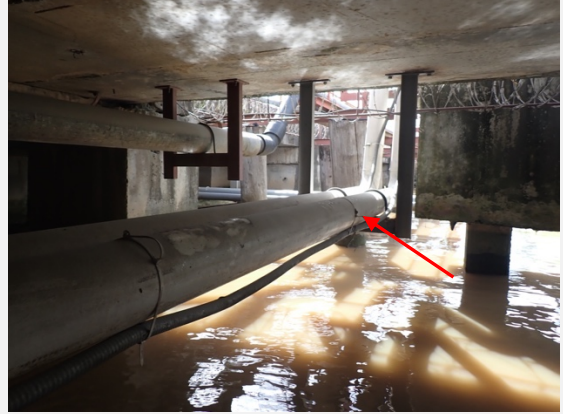
Photo:2  
Comment: General view of the Fuel line running under the wharf – good condition

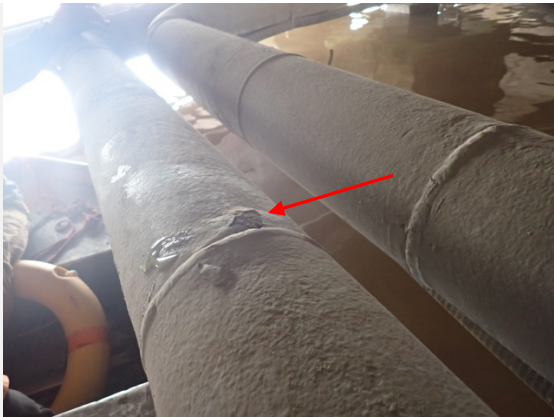
Photo:3  
Comment: Isolated corrosion and minor scale present at 12 o'clock position, at the weld at location 201,202

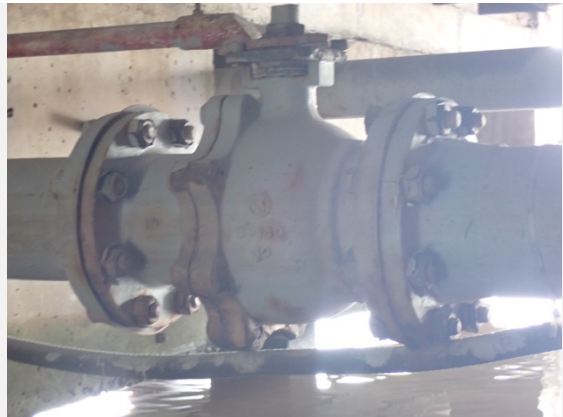
All valves installed on the line, underneath the Berths 1 and 2, suffer from corrosion. All flange fasteners were found corroded, with evidence of some metal loss on the nuts, see photos 4-6, 12-15 and 27-28

Photo:4  
Comment: Valve, located between points 213 and 214. Corroded body and flange fasteners

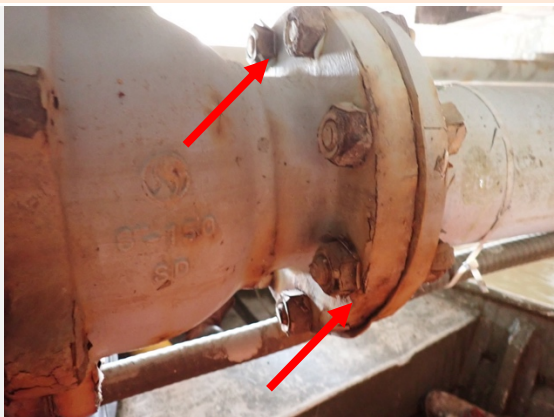
Photo:5  
Comment: Valve, located between points 213 and 214. Evident surface corrosion of the body and heavy corrosion of the flange fasteners

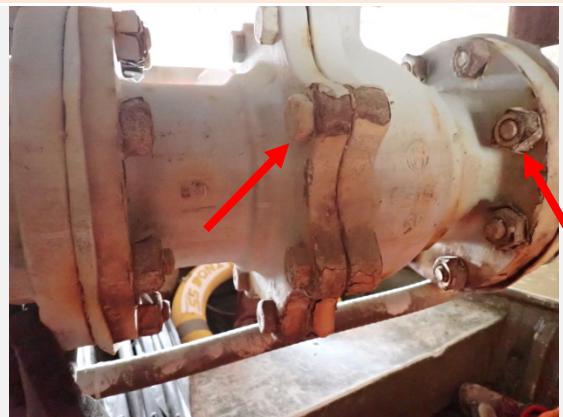
Photo:6  
Comment: Valve, located between points 213 and 214. Evident surface corrosion of the body and heavy corrosion of the flange fasteners

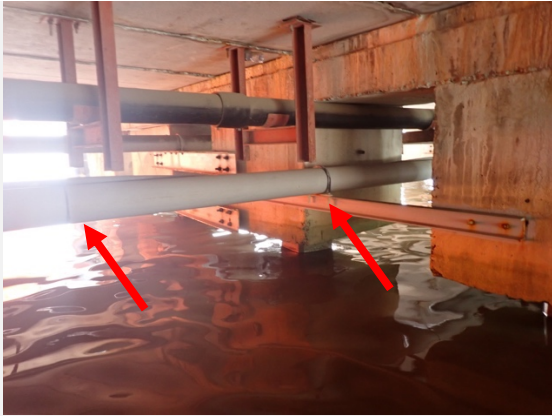
Photo: 7  
Comment: General, good condition of the line, underneath Berth 1. Point 224

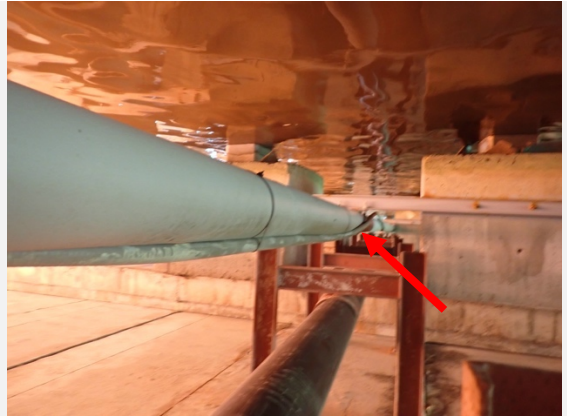
Photo: 8  
Comment: General, good condition of the line, underneath Berth 1. Point 236

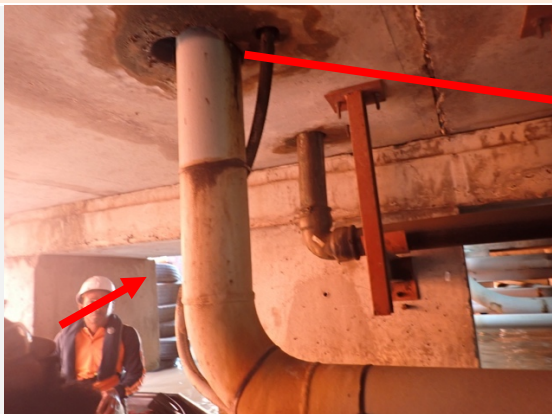
Photo: 9  
Comment: Fuel line, penetration to the Manifold at the Berth 1. Point 251

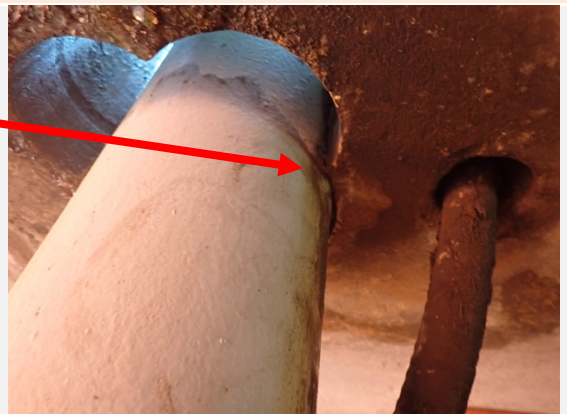
Photo: 10  
Comment: Berth 1 penetration. Pipe in contact with concrete wall.

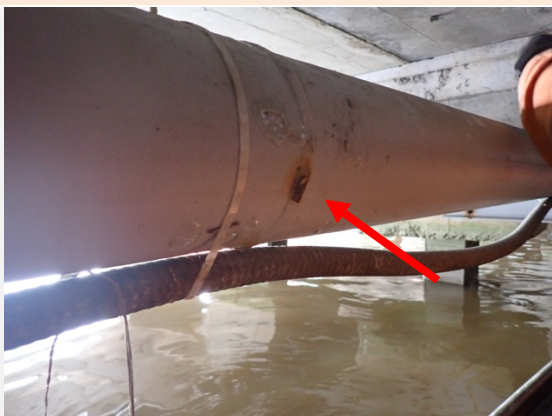
Photo: 11  
Comment: Isolated coating damage and surface corrosion noted on the weld, at point 261, 262.

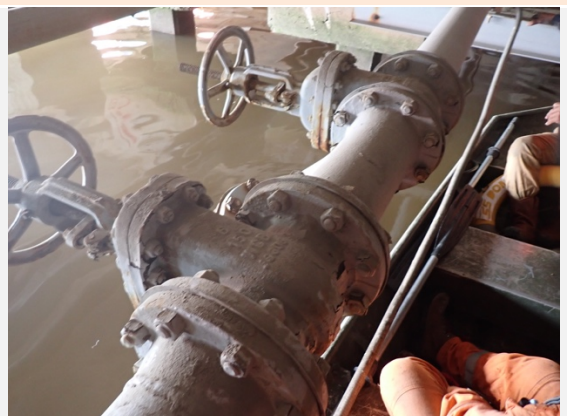
Photo: 12  
Comment: Two isolation valves, at point 264, surface corrosion on the bodies and heavy corrosion noted on the fasteners

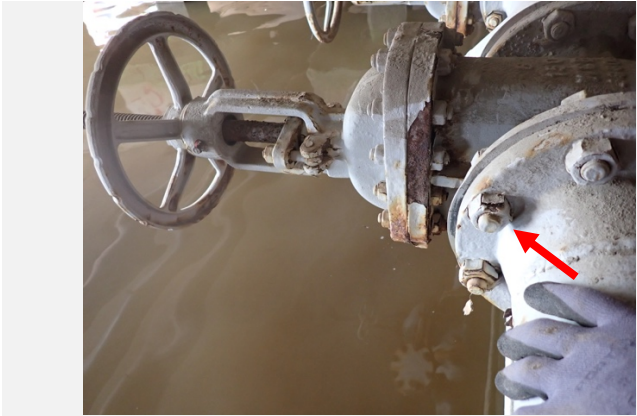
Photo: 13  
Comment: Two isolation valves, at point 264, surface corrosion on the bodies and heavy corrosion noted on the fasteners

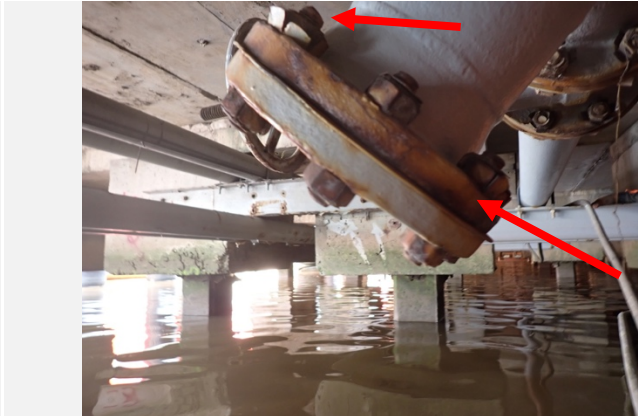
Photo: 14  
Comment: Crevice corrosion and fasteners' corrosion at the blind, installed between two valves.

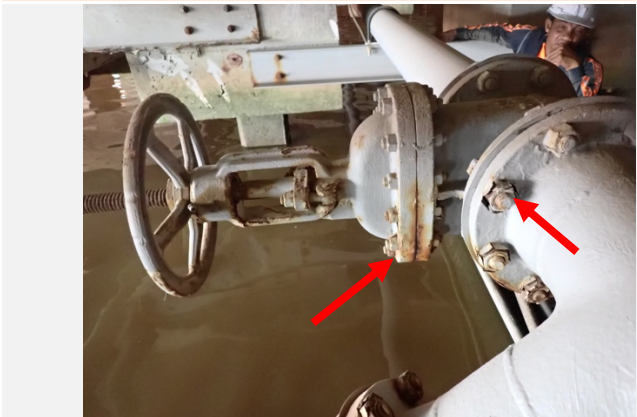
Photo: 15  
Comment: Two isolation valves, at point 264, surface corrosion on the bodies and heavy corrosion noted on the fasteners

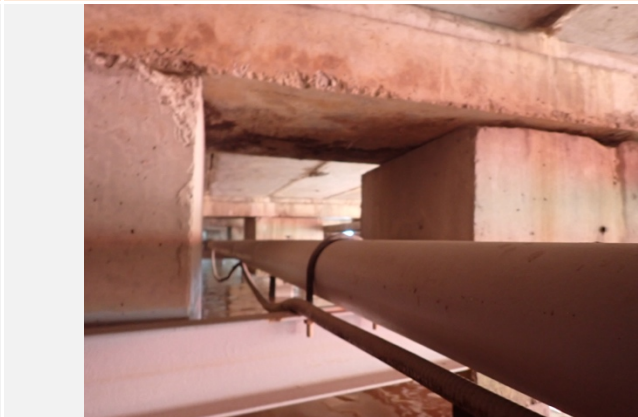
Photo: 16  
Comment: General, good condition of the line, underneath Berth 2. Point 280

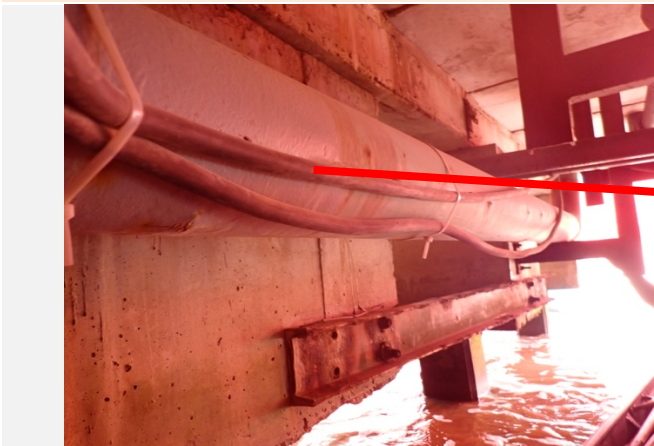
One section of the line, located immediately under the manifold skid, at berth 2 area, was found in poor external condition. Multiple scabs scattered around the section with heavy corrosion scale (5-6mm thick) noted around the weld at the Elbow, location point 295, see photos 17-22. External metal loss evident.

Photo: 17  
Comment: Heavily corroded section of the line, just below the penetration at the manifold, at Berth 2. Multiple areas with corrosion blisters present, location: between point 292 and 299

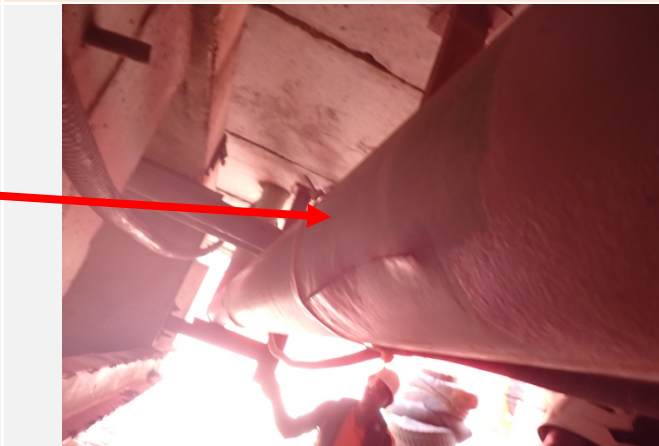
Photo: 18  
Comment: Heavily corroded section of the line, just below the penetration at the manifold, at Berth 2. Multiple areas with corrosion blisters present, location: point 293.

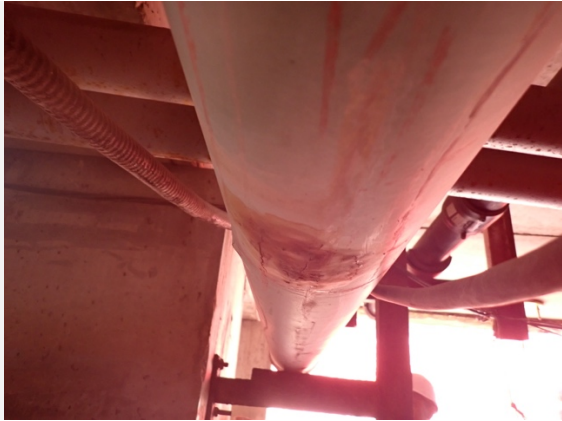
Photo: 19  
Comment: Heavily corroded section of the line, just below the penetration at the manifold, at Berth 2. Multiple areas with corrosion blisters present, location: point 293

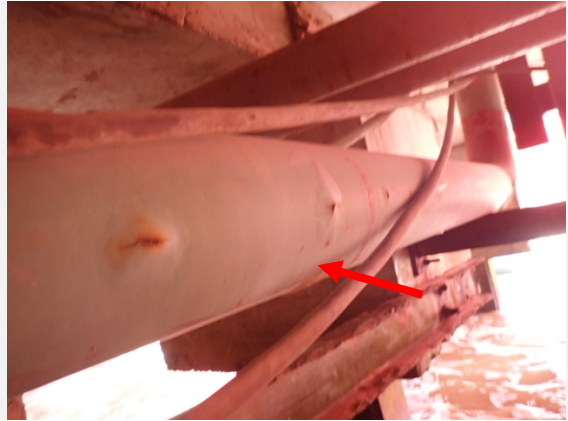
Photo: 20  
Comment: Heavily corroded section of the line, just below the penetration at the manifold, at Berth 2. Multiple areas with corrosion blisters present, location: point 293

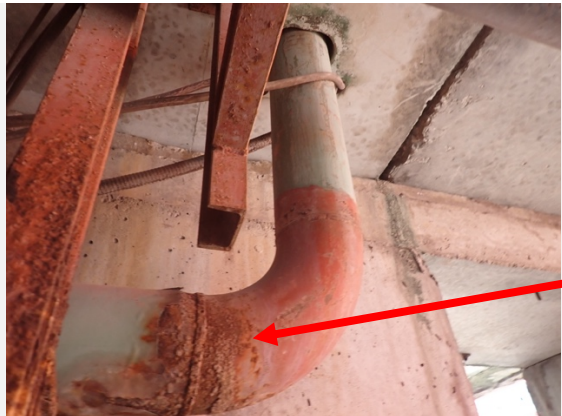
Heavy corrosion scale noted at the elbow, at point location point 295, directly underneath manifold at Berth 2, see photos 21-22. External metal loss evident.

Photo: 21  
Comment: Heavily corroded elbow, just below the penetration at the manifold, at Berth 2. Point 295

| Coating repair to the elbow, at point 295 required. |
| It is suggested to perform follow up UT inspection after the coating repair to estimate wall thickness of the feature. |

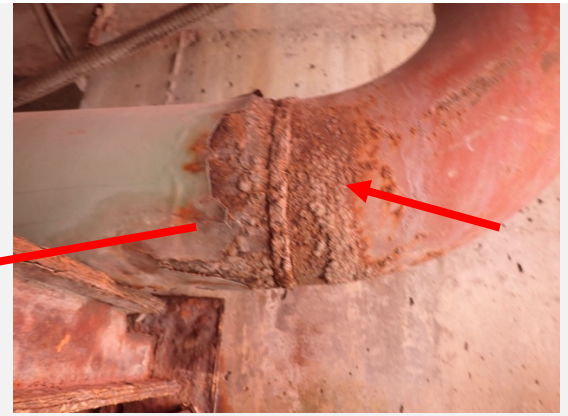
Photo: 22  
Comment: Elbow at point 295. Heavy corrosion scale around entire circumference of the feature.

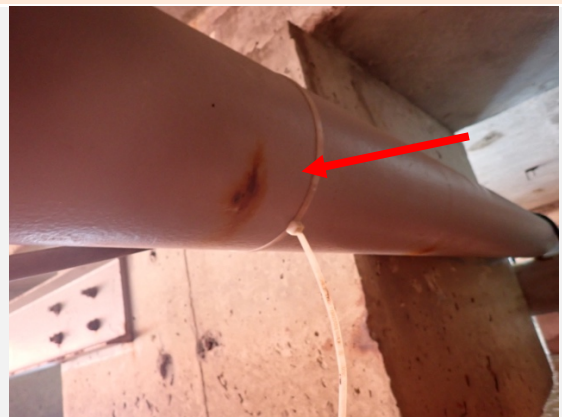
Photo: 23  
Comment: Isolated coating damage and surface corrosion noted on the line, at point 310.

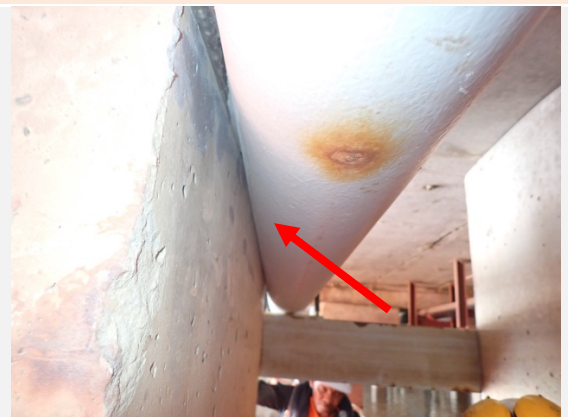
Photo: 24  
Comment: Direct contact, between the line and the concrete wall, at point 310

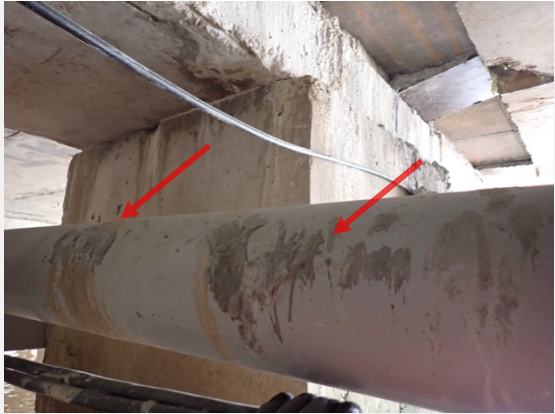
Photo: 25  
Comment: Thick - external, like-concrete, deposits noted at 2 o'clock location, at point 316.

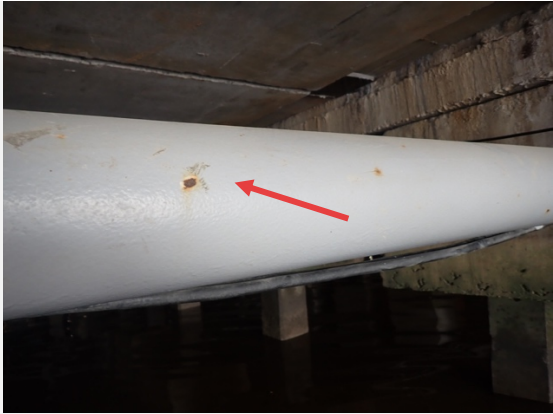
Photo: 26  
Comment: isolated coating damage, at point 316

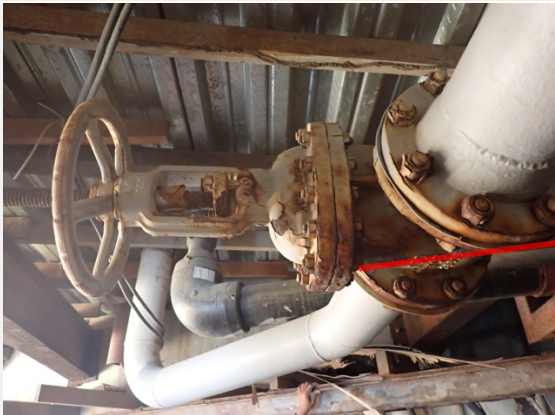
Photo: 27  
Comment: Isolation valve, for the manifold at berth 3, heavy corrosion present on the body and fasteners, location points 347 and 348.

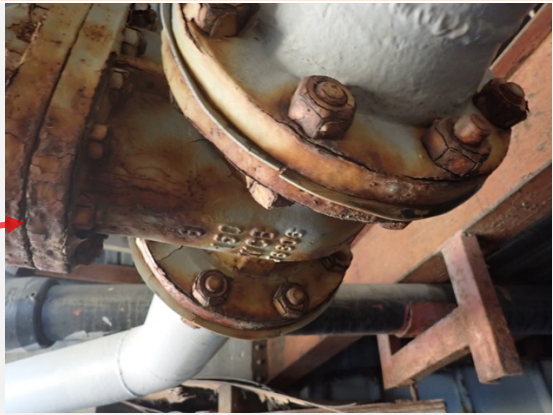
Photo: 28  
Comment: Isolation valve, for the manifold at berth 3, heavy corrosion present on the body and fasteners, location points 347 and 348.

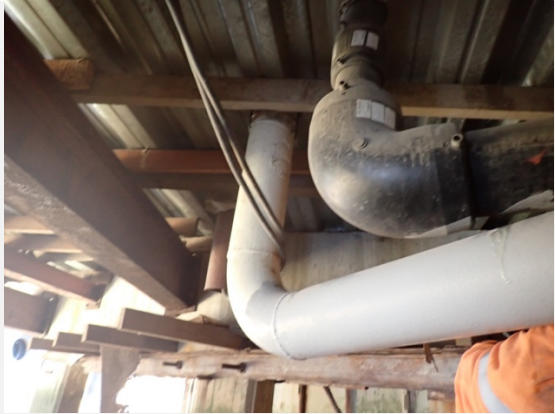
Photo: 29  
Comment: Section of the line, at the penetration to berth 3, good condition
