| | <b>API 570 Inspection on a 6" pipeline</b> | |
| <b>Project Name:</b><br>Fuel line inspection (Berths 3 and 4) | <b>Client Name.:</b><br>Guyana Shore Base Inc. (GYSBI) | <b>Equipment/Tag#:</b><br>Fuel line – Berths 3 and 4 |
| | | <b>Report N-r. :</b><br>APGY/2026/API-03 |

**DATE OF INSPECTION** : 31 July 2026

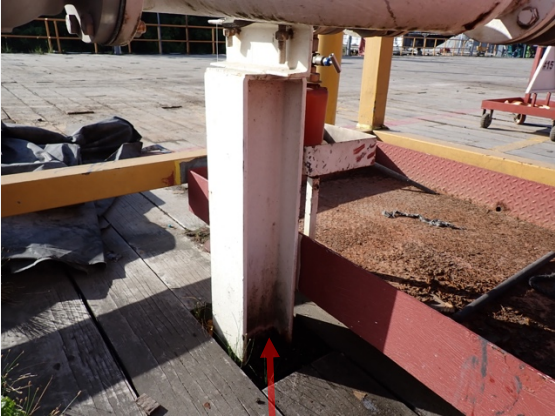
Photo: 1  
Comment: Berth 1 Manifold. PS1 General view of the support at TEE-Piece

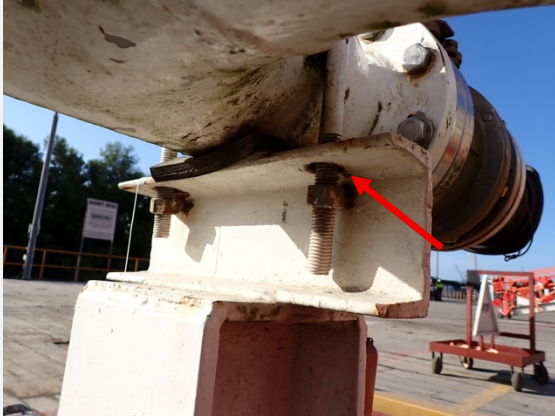
Photo: 2  
Comment: Berth 1 Manifold. Fastener (nut) not done up, possible thread damage.

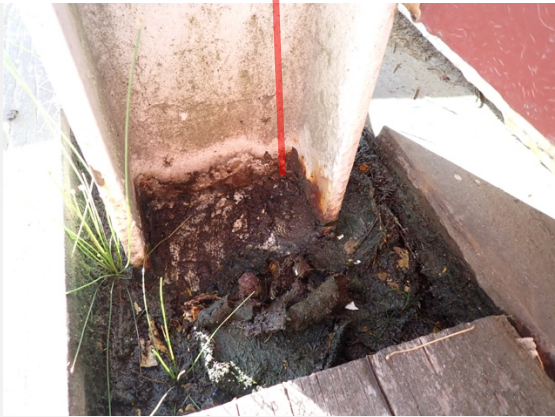
Photo: 3  
Comment: Berth 1 Manifold. Coating damage and the corrosion at the support base.

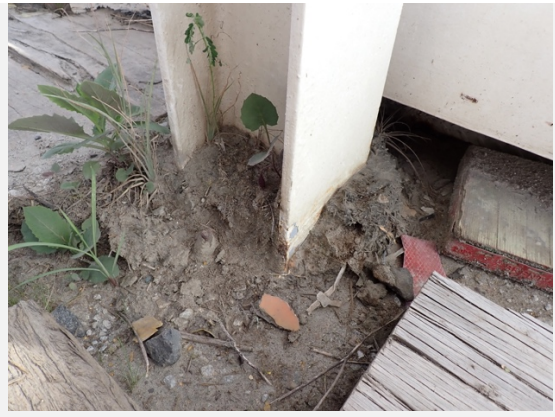
Photo: 4  
Comment: Berth 2 Manifold, the support base covered by soil, coating damage and surface corrosion likely.

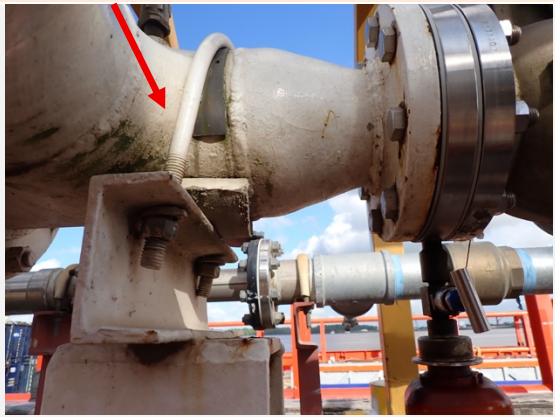
Photo: 5  
Comment: Berth 2 Manifold – U-bolt misaligned due to the geometric constraints of the T-piece.

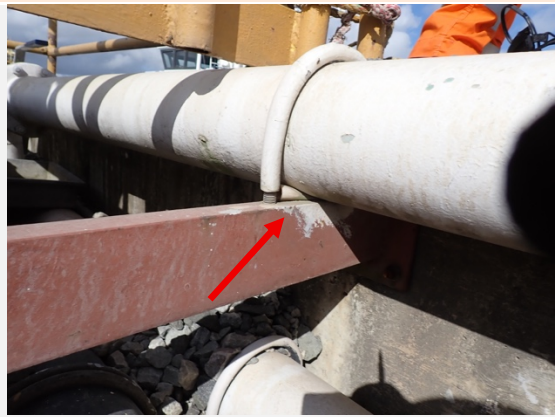
Photo: 6  
Comment: Berth 3 manifold, an elastic rubber tubing used as a shim, typical occurrence to most of the supports on the line.

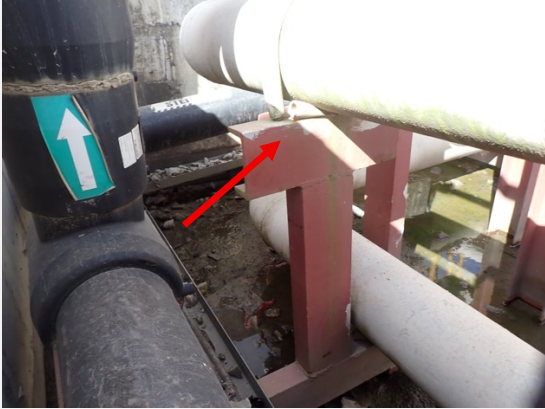
Photo: 7  
Comment: Berth 3 manifold, an elastic rubber tubing used as a shim, PS11, typical occurrence to most of the supports on the line.

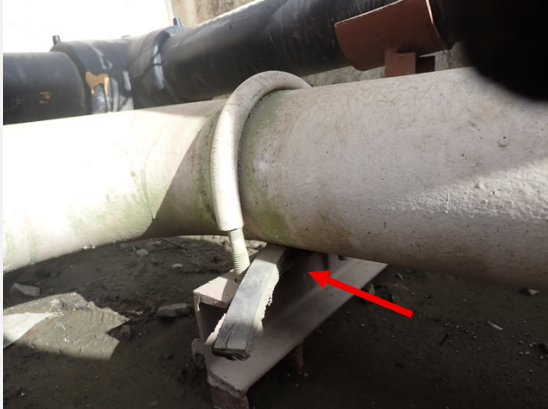
Photo: 8  
Comment: Berth 3. Shim at PS15 not aligned with the support's base.

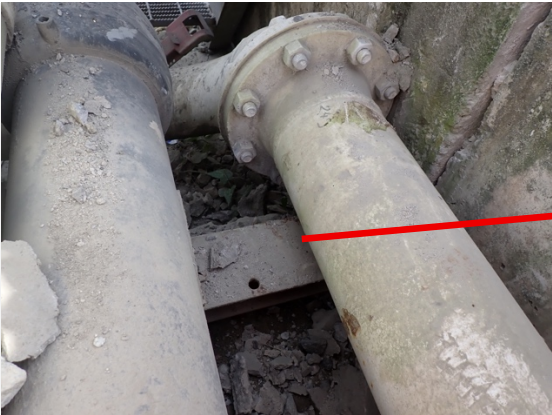
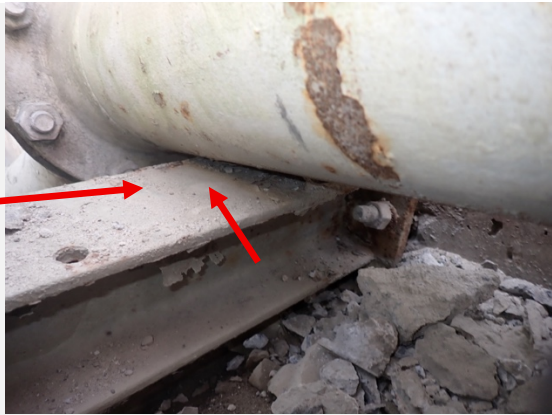
Missing shim and metal-to-metal contact noted, between pipe and support at PS20, at Berth 3, see photos 9 and 10. Shim installation required

Photo: 9  
Comment: Berth 3. Missing shim and metal-to-metal contact between pipe and support at PS20

Photo: 10  
Comment: Berth 3. Missing shim and metal-to-metal contact between pipe and support at PS20

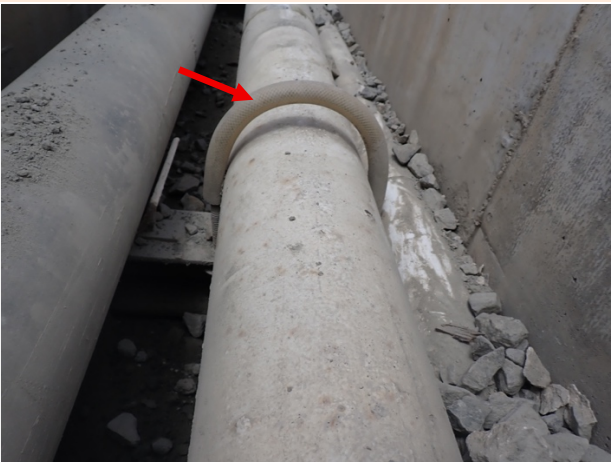
Photo: 11  
Comment: Misaligned U-bolt with airgap present, between top side of the pipe and the U-bolt. Pipe support PS32

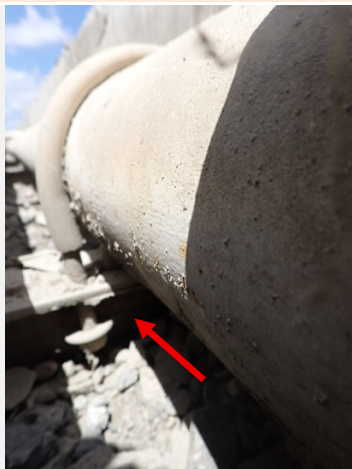
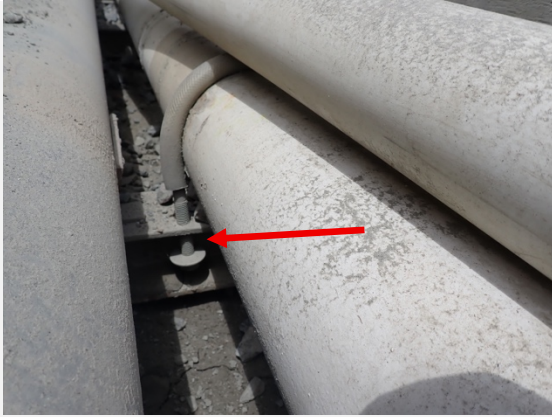
U-bolt supports, between PS24 to PS34, at berth 4 – all fasteners (nut) not done up, possible thread damage, see photos 12-13.

Photo: 12  
Comment: Berth 4. Fastener (nut) not done up, possible thread damage. PS31, typical to all supports, between PS 24 to PS34

Photo: 13  
Comment: Berth 4. Fastener (nut) not done up, possible thread damage. PS32, typical to all supports, between PS 24 to PS34

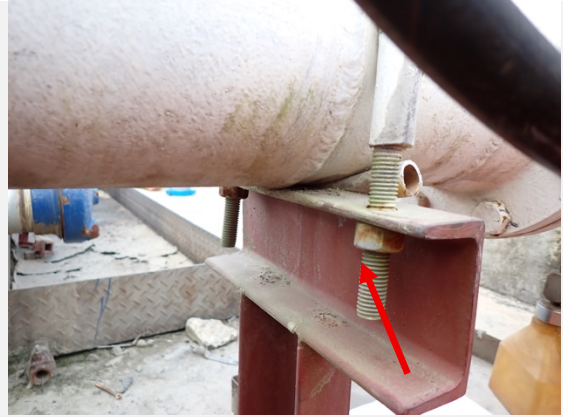
Damaged shim and metal-to-metal contact between pipe and support noted at support PS39, at Berth 4, see photo 14. Repair required

Photo: 14  
Comment: Berth 4. Damaged shim and metal-to-metal contact between pipe and support at PS39

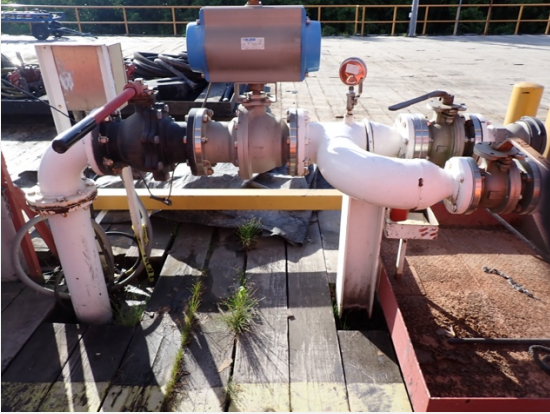
Photo: 1  
Comment: Berth 1 Manifold. General view.

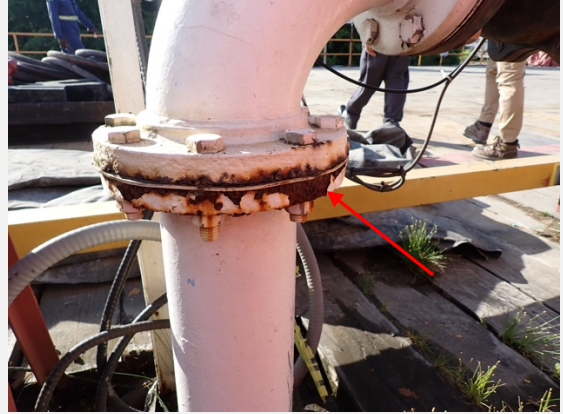
Photo:2  
Comment: Berth 1 Manifold. Crevice corrosion at the flange, at point 2.

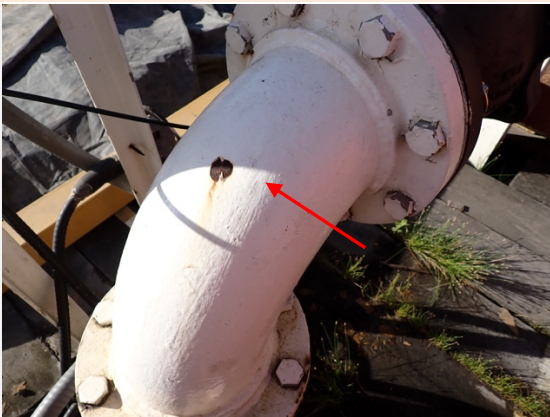
Photo:3  
Comment: Berth 1 Manifold. Isolated coating damage area at elbow extrados, at point 4.

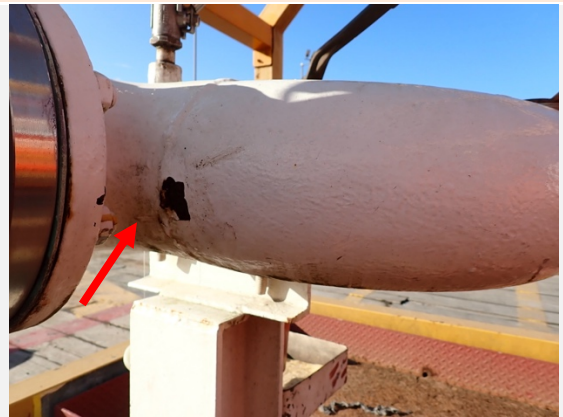
Photo:4  
Comment: Berth 1 Manifold, isolated coating damage and surface corrosion at the weld at point 10.

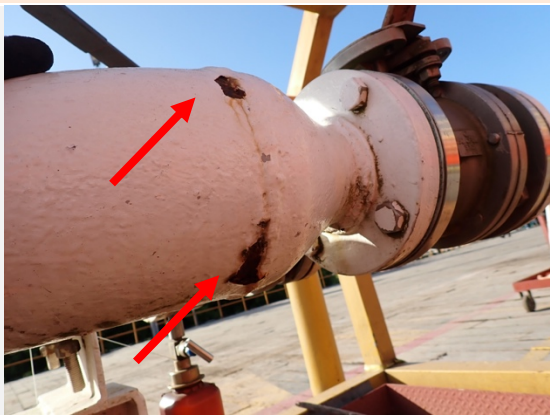
Photo:5  
Comment: Berth 1 Manifold, isolated coating damage and surface corrosion at the weld at point 12.

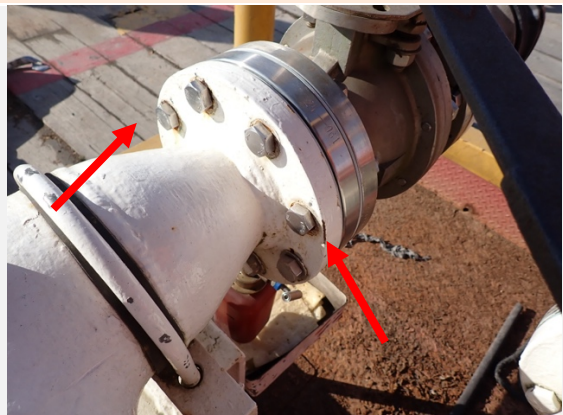
At the manifolds, at Berths 1,2 3, the terminating valves are made of Stainless Steel, with stainless steel fasteners, installed without isolating kits, on carbon steel flanges and blinds, causing galvanic corrosion to the cs parts.

Photo:6  
Comment: Berth 1 Manifold, SS bolts used without any insulation on the carbon steel flange. Danger of galvanic corrosion.

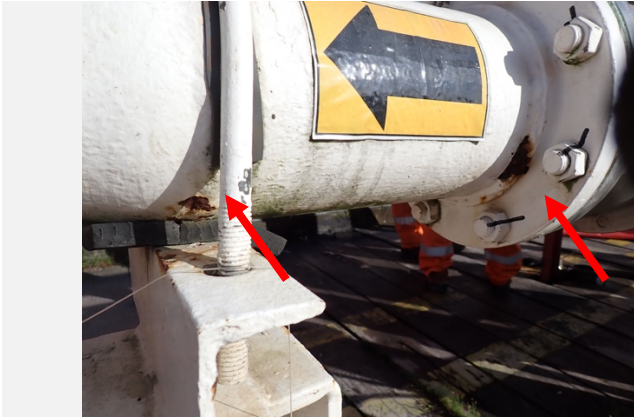
Photo: 7  
Comment: Berth 1 Manifold, isolated coating damage and surface corrosion at the weld at point 6 & 8.

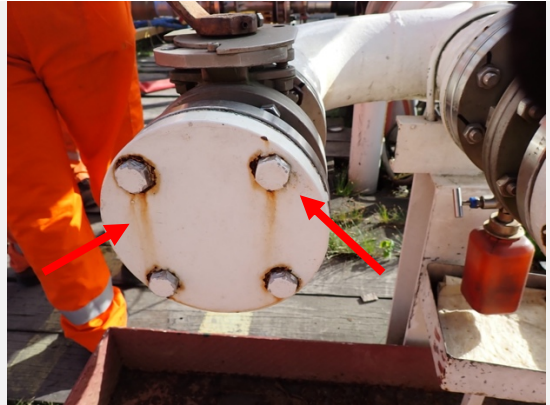
Photo: 8  
Comment: Berth 1 Manifold. Galvanic corrosion at the interface of SS fasteners and CS blind.

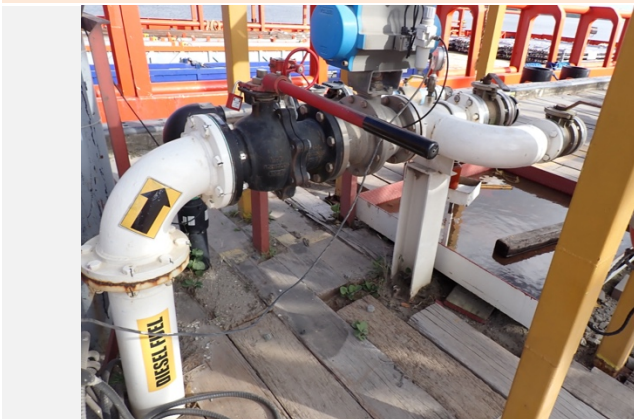
Photo: 9  
Comment: Berth 2 Manifold. General view.

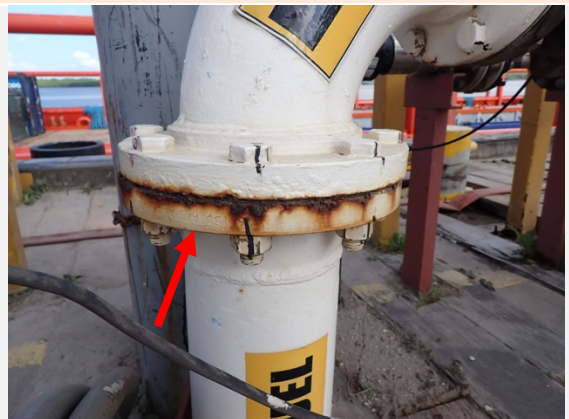
Photo: 10  
Comment: Berth 2 Manifold. Crevice corrosion at the flange, at point 2.

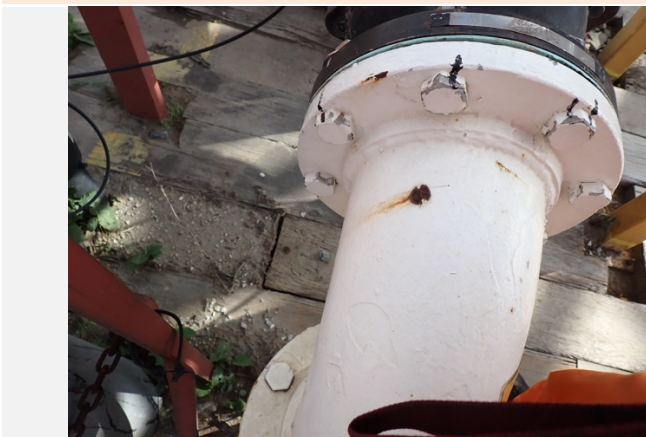
Photo: 11  
Comment: Berth 2 Manifold. Isolated coating damage area at elbow extrados, at point 4.

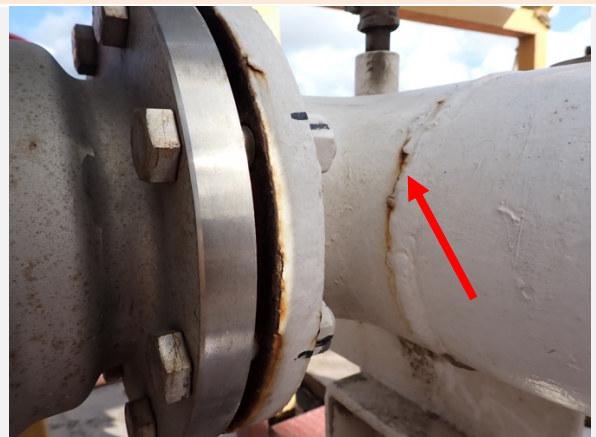
Photo: 12  
Comment: Berth 2 Manifold, SS bolts used without any insulation on the carbon steel flange. Danger of galvanic corrosion. Surface corrosion noted at weld at point 10.

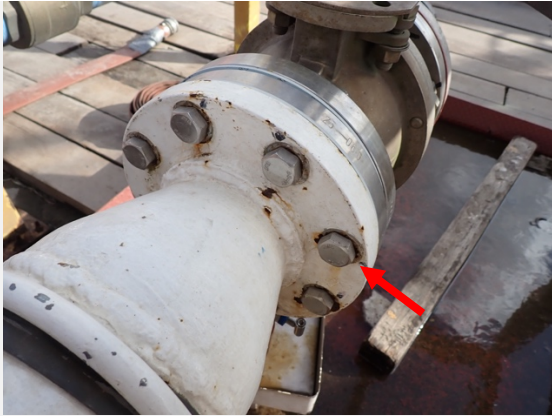
Photo: 13  
Comment: Comment: Berth 2 Manifold, SS bolts used without any insulation on the carbon steel flange.

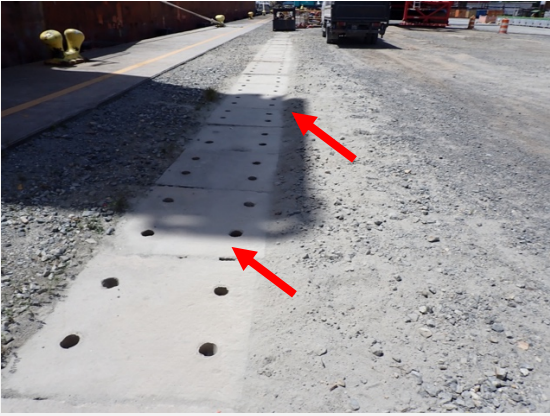
Photo: 14  
Comment: Berth 3. Utilidor with the covers on. General view

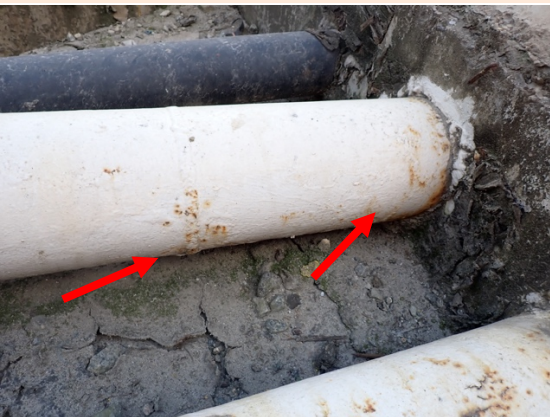
Photo: 16  
Comment: Berth 3. Minor surface corrosion rust spots noted at the line, at the point 1.

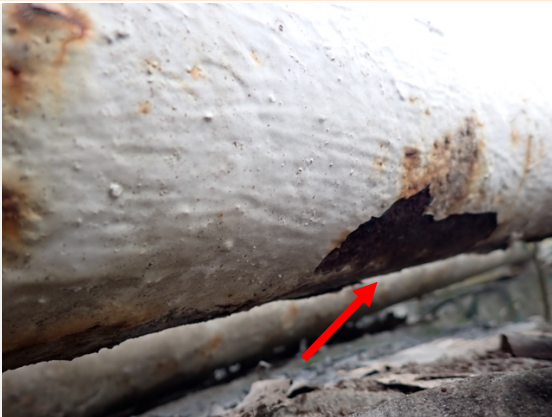
Photo: 17  
Comment: Berth 3. Isolated coating damage and surface corrosion, located at 6 o'clock position at point 4.

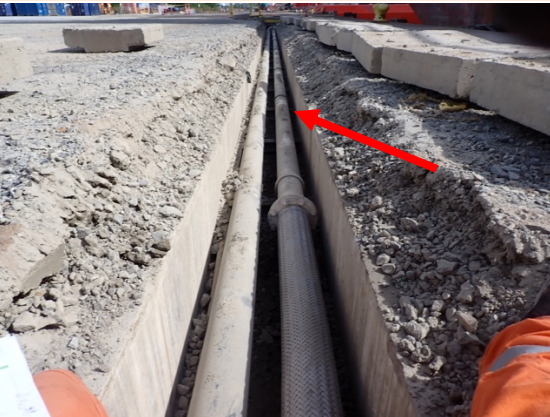
Photo: 18  
Comment: Berth 3. General view of the line installed inside the utilidor, with covers lifted.

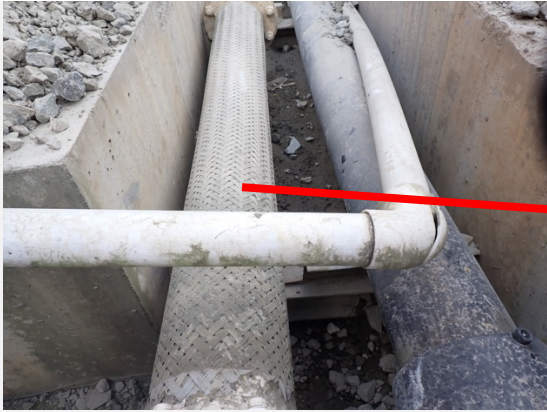
Photo: 19  
Comment: Berth 3. A flexible, SS metal braided spool, installed on the line, at position 14-15. Found in generally good condition.

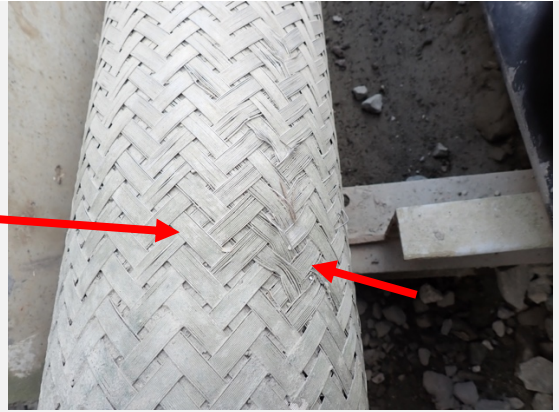
Photo: 20  
Comment: isolated, minor ss braid damage, noted at 12 o'clock.

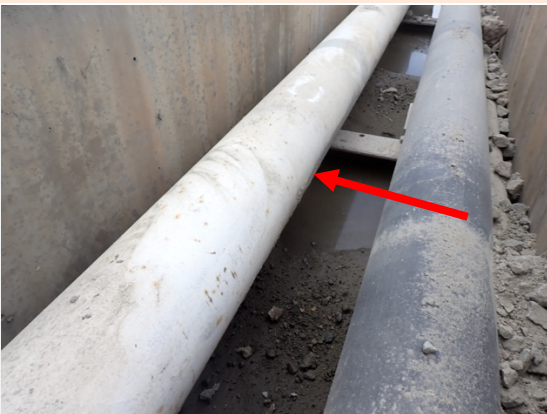
Photo: 21  
Comment: Berth 3. General view, scattered minor rust spots along the entire line.

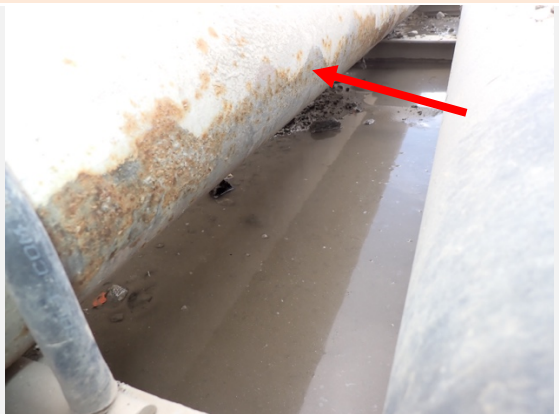
Missing topcoat at the bottom half of the pipe, noted along the section at Berth 3, upstream of manifold 3. Section between points 15 and 28. Surface cleaning and re-coating, as per company procedure required.

Photo: 22  
Comment: Berth 3. General view, topcoat missing at the bottom half, along the line at the berth 3, upstream of manifold. Surface corrosion noted.

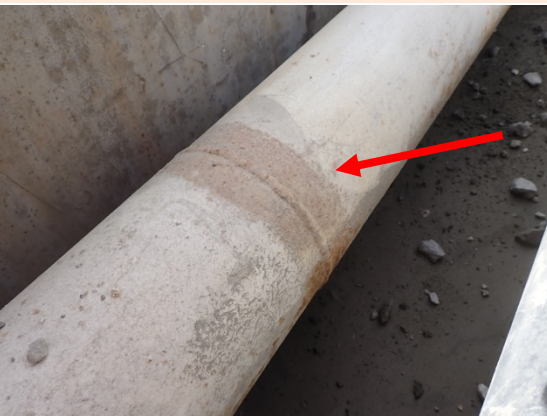
Photo: 23  
Comment: Berth 3. Surface corrosion noted around weld, at point 20,21. Previously removed coating around the weld, was not re-applied.

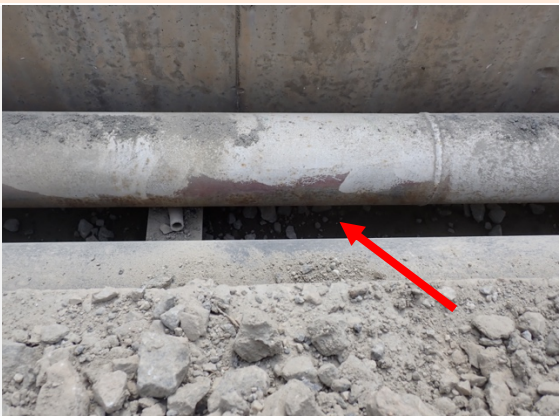
Photo: 24  
Comment: Berth 3. General view, topcoat missing at the bottom half, along the line at the berth 3, upstream of manifold

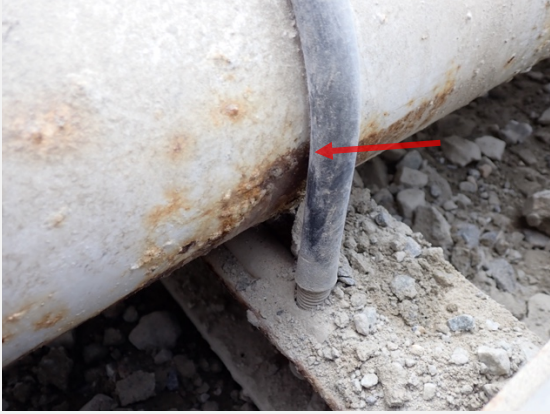
Photo: 25  
Comment: Berth 3. Isolated spot with coating damage and surface corrosion, at pipe support, PS7

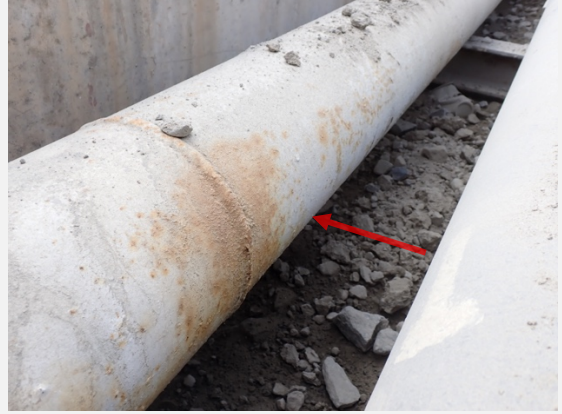
Photo: 26  
Comment: Berth 3. Rusting spots at weld, point 26, 27

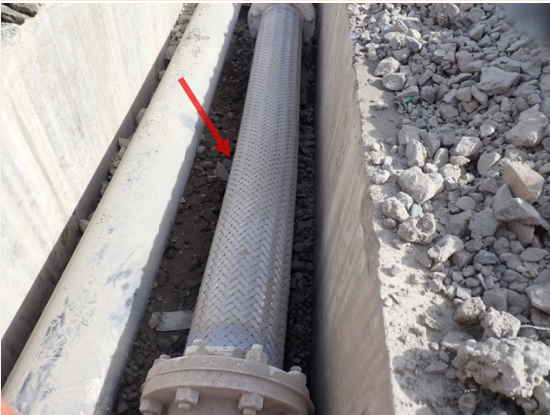
Photo: 27  
Comment: Berth 3. A flexible, SS metal braided spool, installed on the line, at position 28-29. Found in good condition.

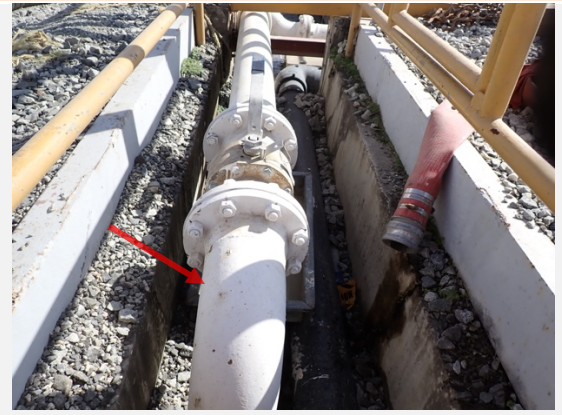
Photo: 28  
Comment: Berth 3. Minor, mechanical coating damage areas (paint chips). Elbow, point 38.

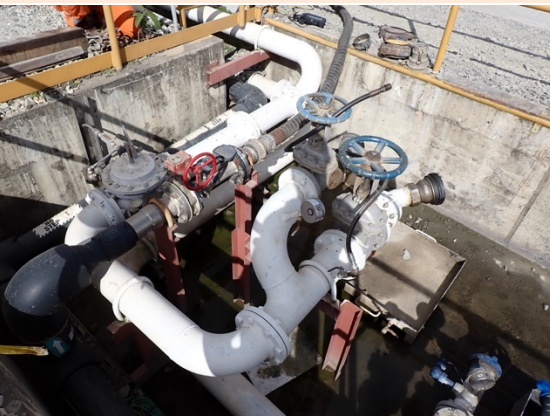
Photo: 29  
Comment: Berth 3. General view of the manifold 3.

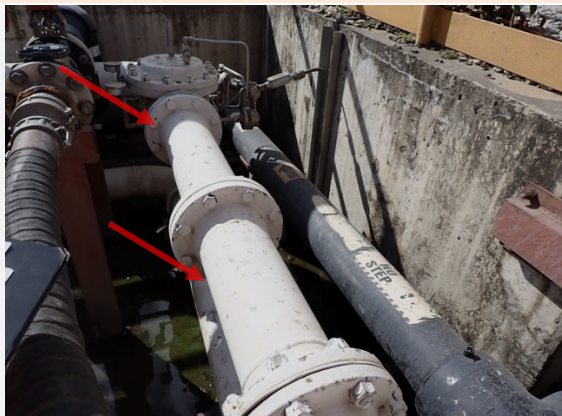
Photo: 30  
Comment: Berth 3. Minor, mechanical coating damage areas (paint chips). Spools, between points 47 and 53.

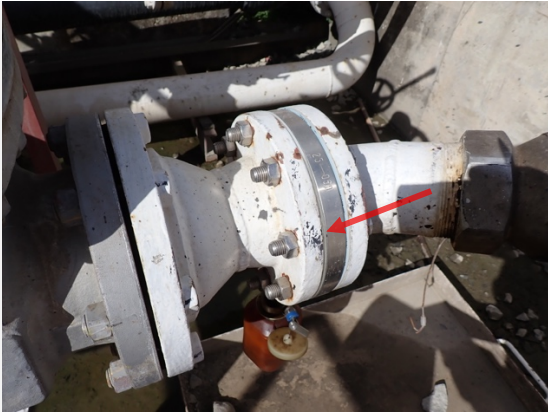
Photo: 31  
Comment: Berth 3, Manifold 3 – no insulating kits between stainless steel bolts and carbon steel flange, at point 74

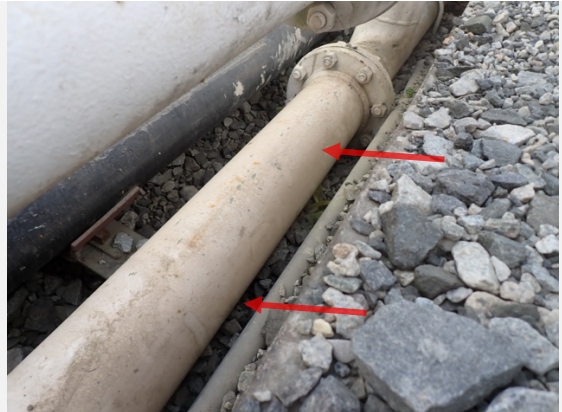
Photo: 32  
Comment: Berth 3, Minor, mechanical coating damage areas (paint chips). Spool, between points 77 and 79.

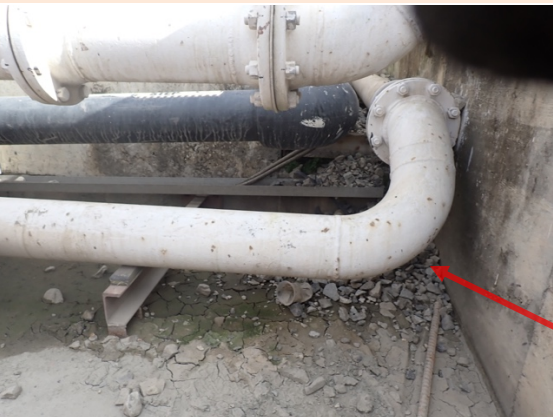
Photo: 33  
Comment: Berth 3, Minor, mechanical coating damage areas (paint chips). Spool, between points 80 and 89.

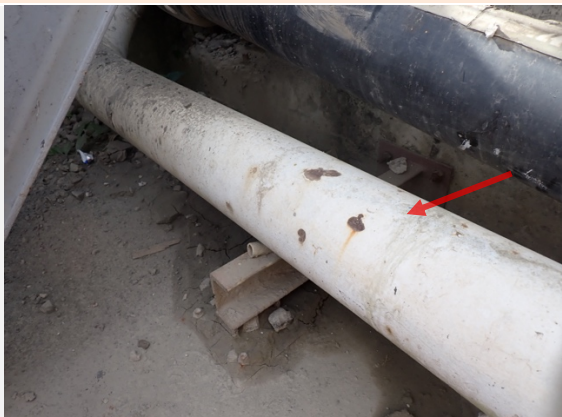
Photo: 34  
Comment: Berth 3, Scattered coating damage areas, with surface corrosion, at point 100.

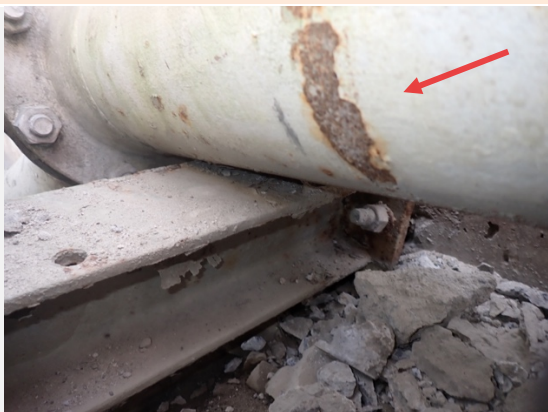
Photo: 35  
Comment: Berth 3. Coating damage and surface corrosion, noted at 4 o'clock location at support area, PS20

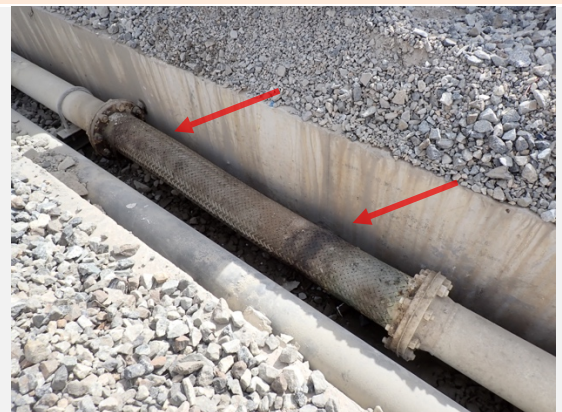
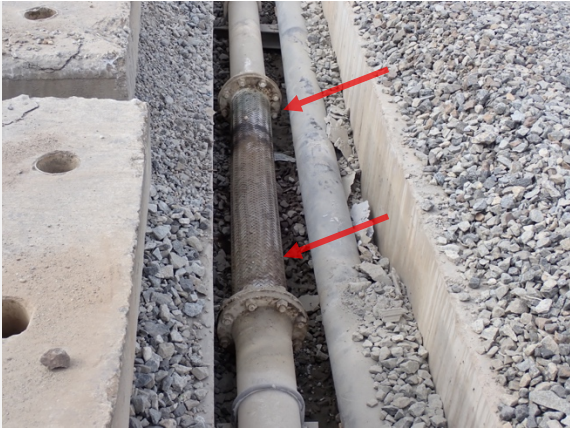
Photo: 37

Evidence of seep/leak was noted at the 5ft long, flexible, metal braided spool, installed at the piping, inside the utilidor, at Berth 3 area, see photos 36 and 37.

Photo: 36  
Comment: Evidence of seep/leak was noted at the 5ft long, flexible, metal braided spool, position between points 109 and 110

Comment: Evidence of seep/leak was noted at the 5ft long, flexible, metal braided spool, position between points 109 and 110

The Fuel Farm supervisor was informed, and the replacement was recommended.

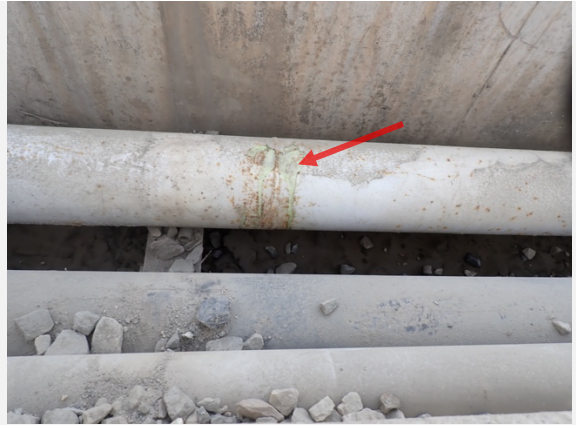
Photo: 38

Comment: Berth 3. Surface corrosion noted around weld, at point 112, 113. Previously removed coating around the weld, was not re-applied.

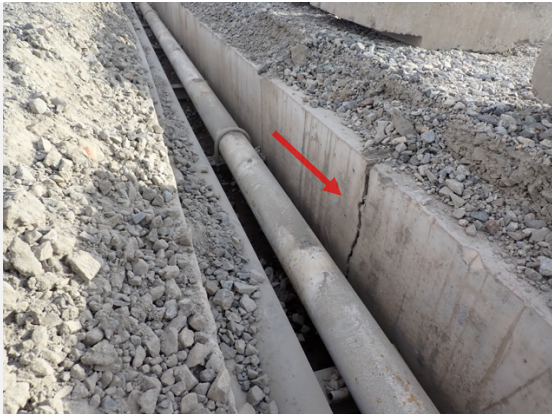
Photo: 39

Vertical cracks at the concrete walls, at the utilidor walls, noted at berth 3 and 4, see photos 39 and 42. Concrete repair required.

Comment: Berth 3. Vertical crack at the concrete wall of the utilidor at location, between points 110 and 112

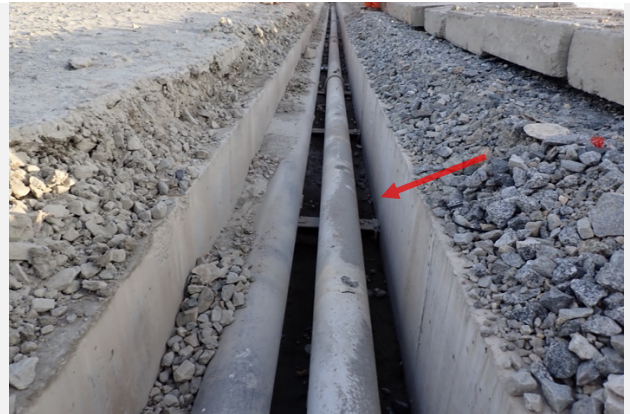
Photo: 40

Comment: Berth 3. General view of the line installed inside the utilidor, between points 110 and 123, with covers lifted.

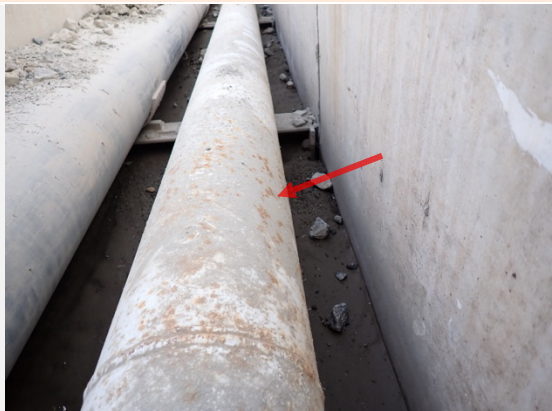
Photo: 41

Comment: Berth 3, scattered rusting points at line, location point 121, 122.

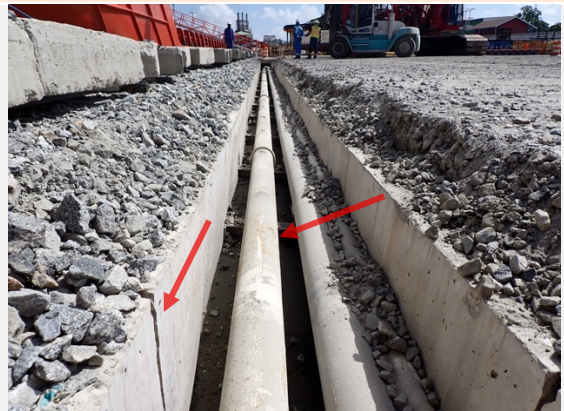
Photo: 42

Comment: Berth 4. General view of the line at the utilidor, vertical crack at the concrete wall, point 123

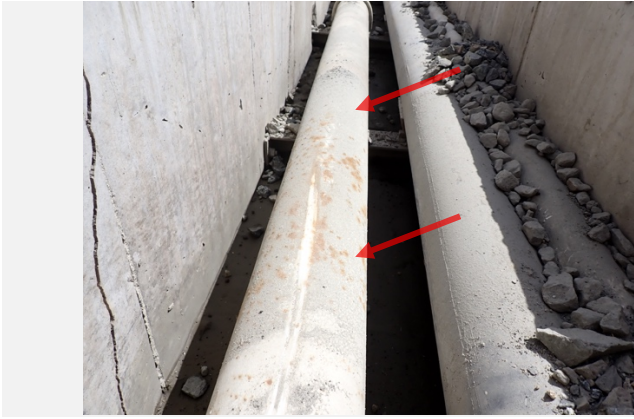
Photo: 43  
Comment: Berth 4, scattered rusting points at line, location point 123.

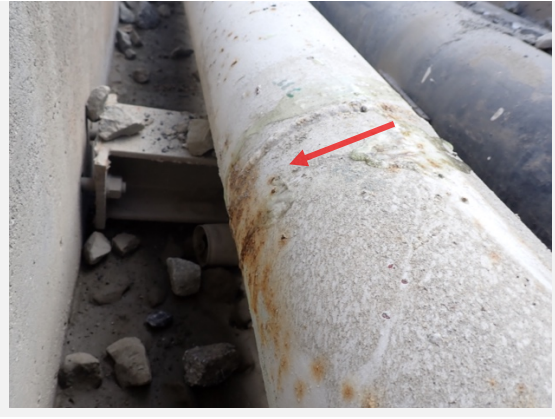
Photo: 44  
Comment: Berth 4. Isolated coating damage and rusting spots noted at 9 o'clock location at weld point 130, 131

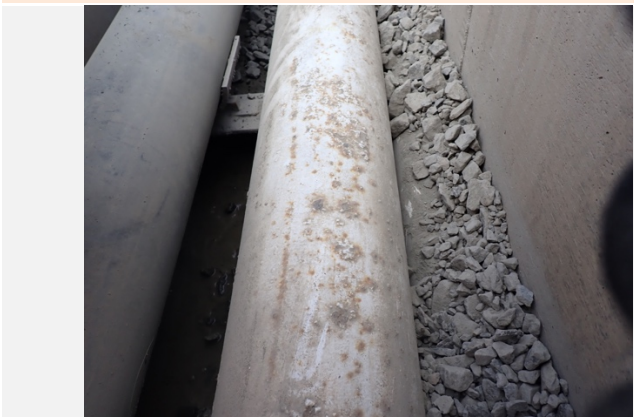
Photo: 45  
Comment: Berth 4. Scattered corrosion blisters note at 12 o'clock location at line, point 144.

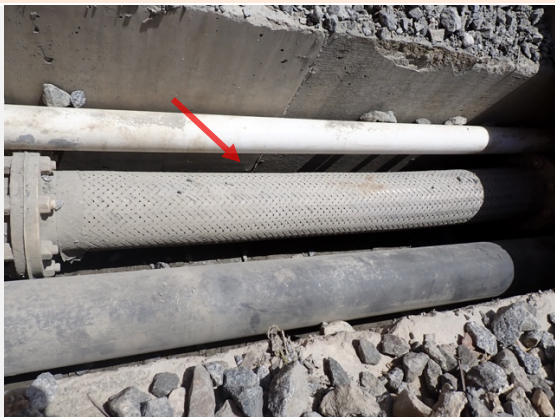
Photo: 46  
Comment: Berth 4. A flexible, SS metal braided spool, installed on the line, at position 148-149. Found in good condition.

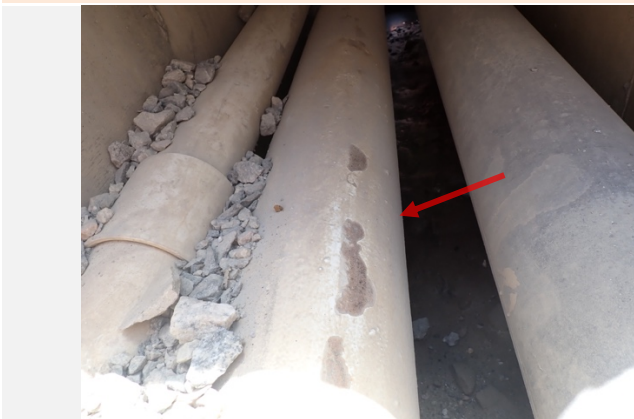
Photo: 47  
Comment: Berth 4. Coating damage noted at 12 o'clock location at position 147.

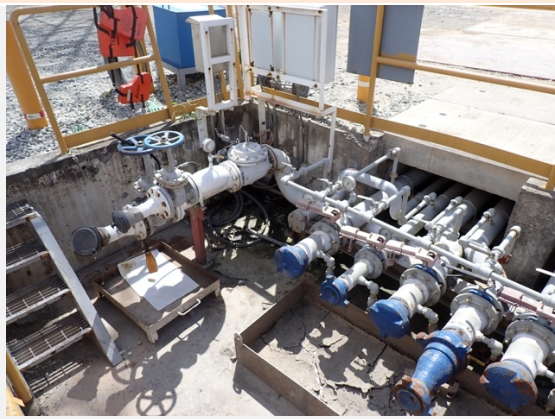
Photo: 48  
Comment: Berth 4. General view of the manifold 4.

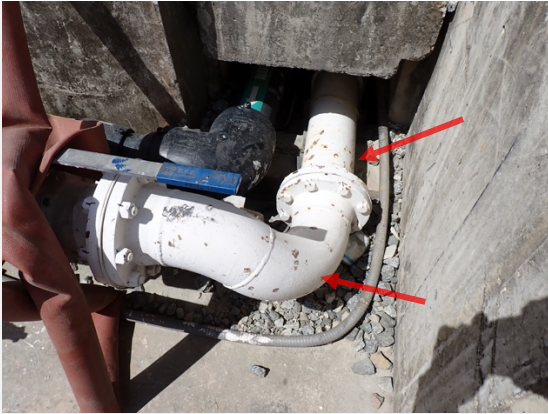
Photo: 49  
Comment: Berth 4. Scattered coating damage noted at location between points 150 and 157.

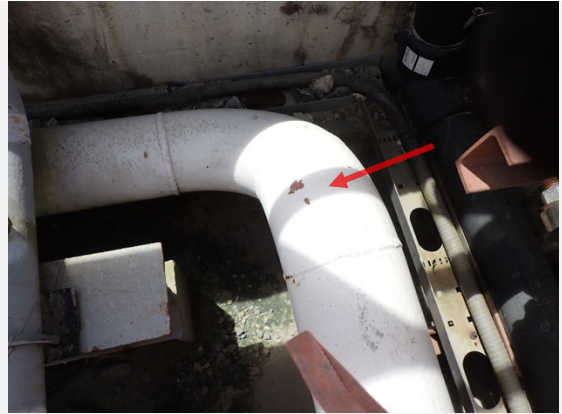
Photo: 50  
Comment: Berth 4, isolated coating damage at elbow at point 165

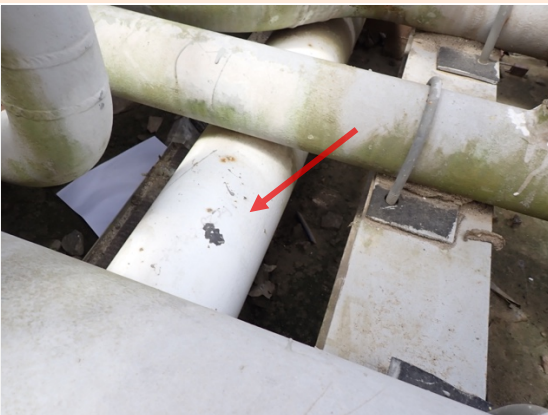
Photo: 51  
Comment: Berth 4. Isolated coating damages at the line at point 170

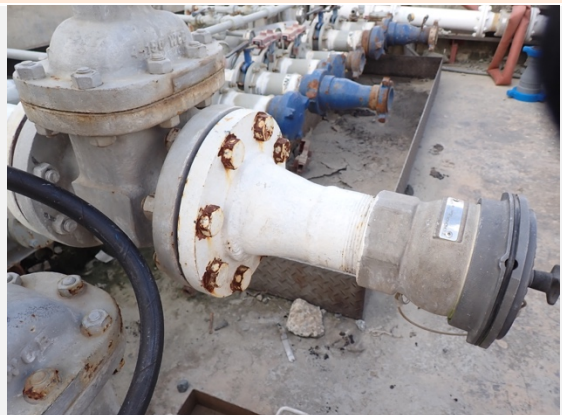
Photo: 52  
Comment: Berth 4. Surface corrosion around and at the fasteners at the termination spool at point 186

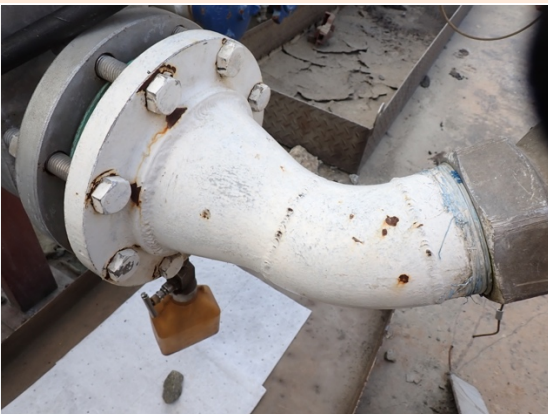
Photo: 53  
Comment: Berth 4. Isolated coating damages at the termination spool at point 190.
