| | <b>API 570 Inspection on a 6" pipeline</b> | |
| <b>Project Name:</b><br>Fuel line inspection (Gysbi to Wharf) | <b>Client Name.:</b><br>Guyana Shore Base Inc. (GYSBI) | <b>Equipment/Tag#:</b><br>Fuel line –Gysbi to Wharf |
| | | <b>Report N-r. :</b><br>APGY/2026/API-02 |

## API 570 Inspection on a 6" piping Fuel line (Gysbi to Wharf)

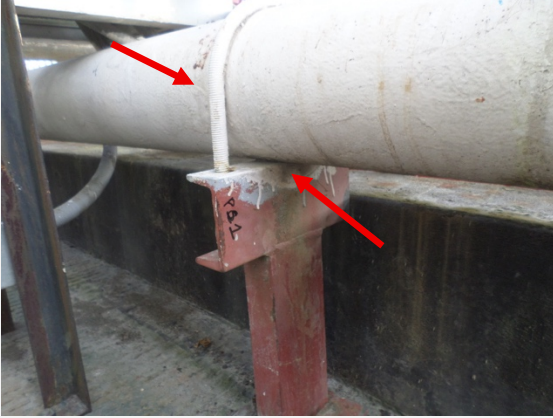
**Photo: 1**  
**Comment:** Pipe support PS1 - No Insulation installed between U-Bolt support and the Pipe surface. Metal-to-metal contact, corrosion prone, to be replaced with I-Rod system

Three supports (PS1, PS2 and PS3) noted without adequate isolation between piping and metal supports. Corrosion evidence noted underneath fabric, installed at PS2 and PS3. Recommending installation of I-Rod like system, at the supports.

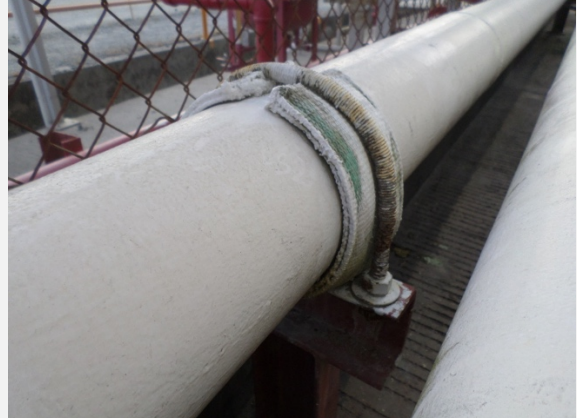
**Photo: 2**  
**Comment:** Pipe support PS2- Random fabric used as U-bolt sleeve, possible corrosion under the fabric. To be replaced with I-Rod system

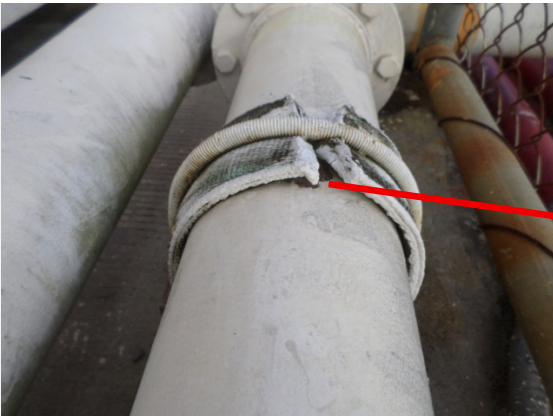
**Photo: 3**  
**Comment:** Pipe support PS3- Random fabric used as U-bolt sleeve, possible corrosion under the fabric. To be replaced with I-Rod system

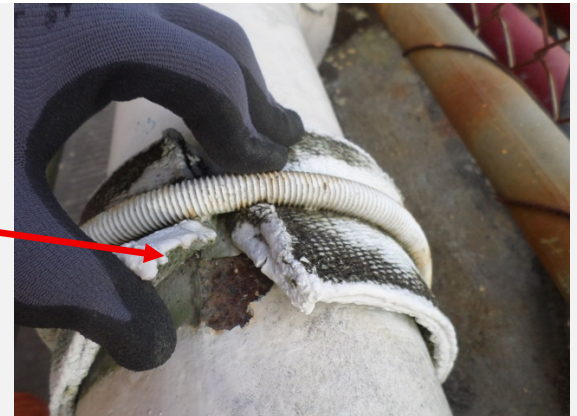
**Photo: 4**  
**Comment:** PS3 – evidence of coating breakdown and corrosion evident under the fabric.

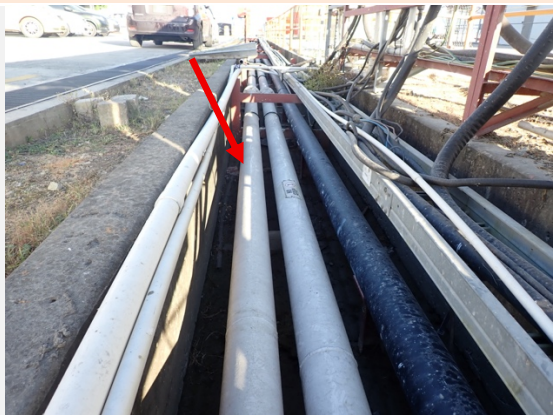
**Photo: 5**  
**Comment:** Area of the line from PS18 to PS24, where the supports are positioned in the water. No access to the base of the supports, possible corrosion under the water level.

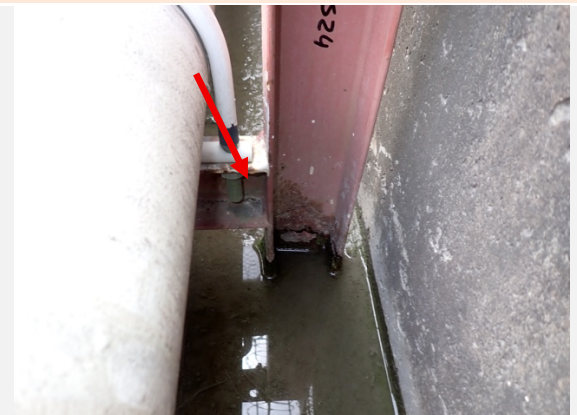
**Photo: 6**  
**Comment:** Pipe support PS24, base covered by standing water, surface corrosion present at the base.

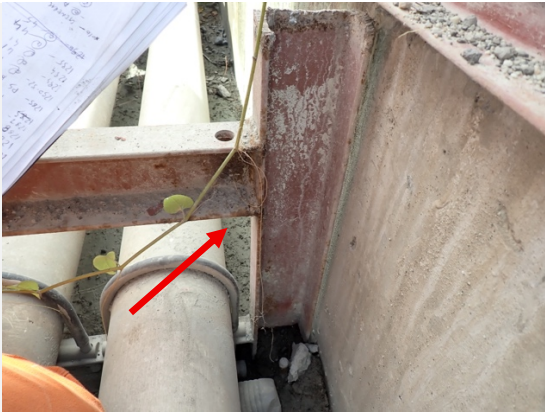
Photo: 7  
Comment: Pipe support PS27 – normally located underneath the steel bridge. Surface corrosion on the support, compact soil and water present at the base.

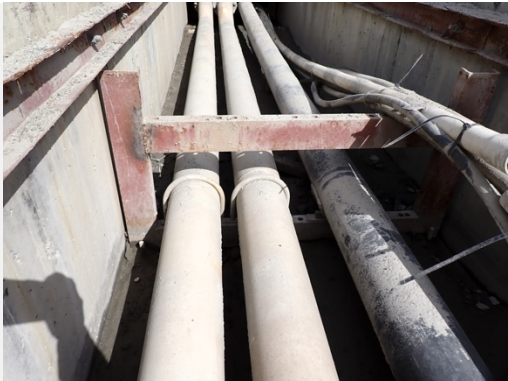
Photo: 8  
Comment: Pipe support PS28 – normally located underneath the steel bridge. Surface corrosion on the support, compact soil and water present at the base.

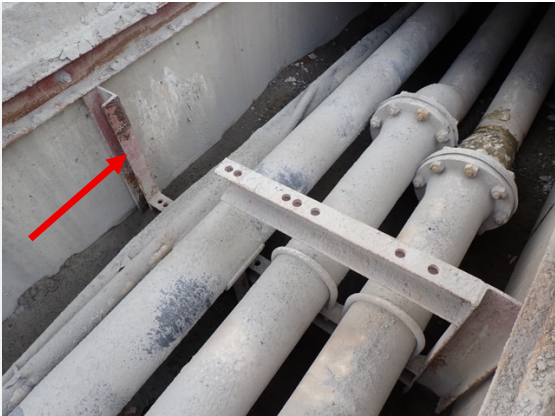
Two supports: PS27 and PS28, normally located underneath the steel bridge crossing, were noted with top bracing cut-off, see photos 9 and 10. Not resulting in immediate danger of collapsing. To be monitored.

Photo: 9  
Comment: Pipe support PS27 – normally located underneath the steel bridge. Surface corrosion on the support. Top bracing cut-off

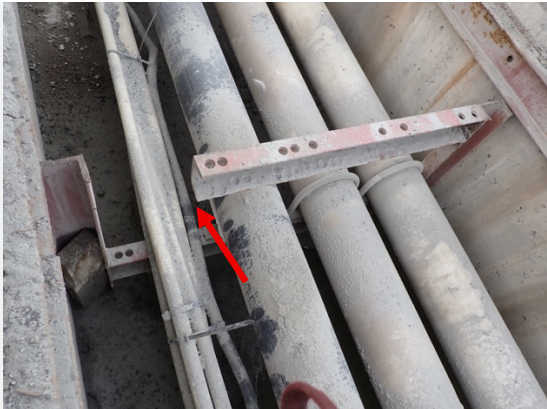
Photo: 10  
Comment: Pipe support PS28 – normally located underneath the steel bridge. Surface corrosion on the support. Top bracing cut-off

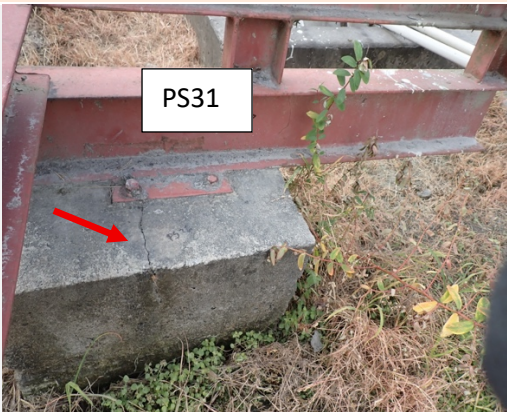
Photo: 11  
Comment: PS31 – Concrete foundation – A, with crack running down the center

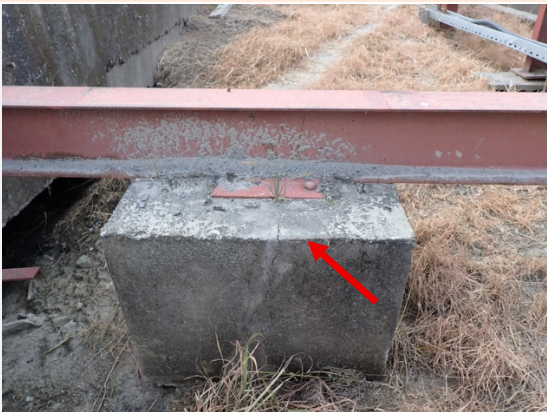
Photo: 12  
Comment: PS31 – Concrete foundation- B, with crack running down the center

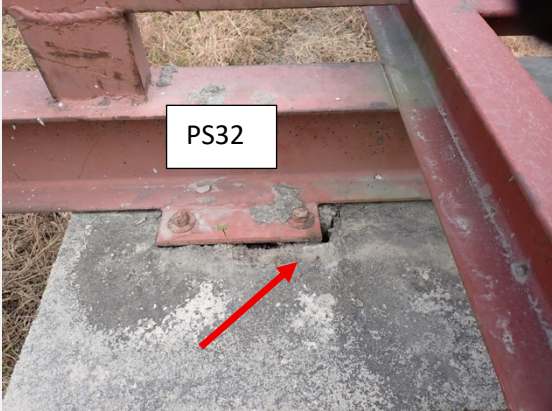
Photo: 13  
Comment: PS32 – Concrete foundation, damaged, hollow space under the base plate

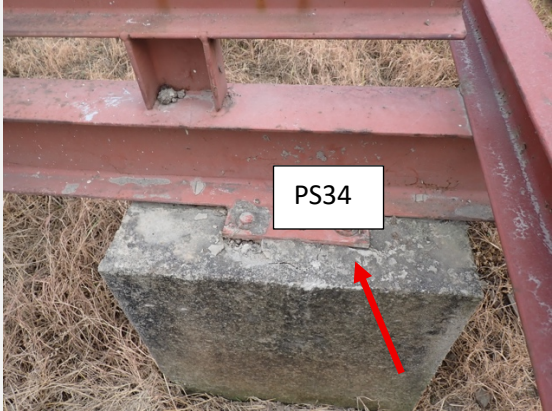
Photo: 14  
Comment: PS34 – Concrete foundation, cracks around the base plate

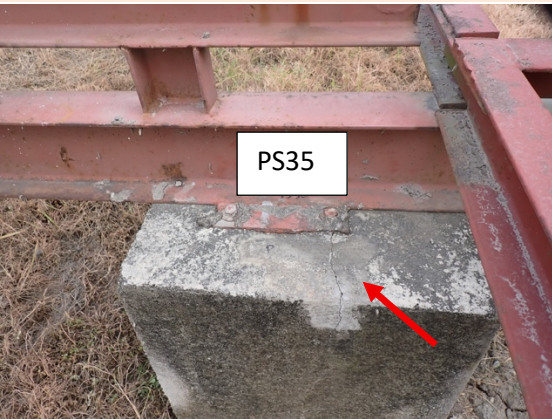
Photo: 15  
Comment: PS35 – Concrete foundation - A, with crack running down the center

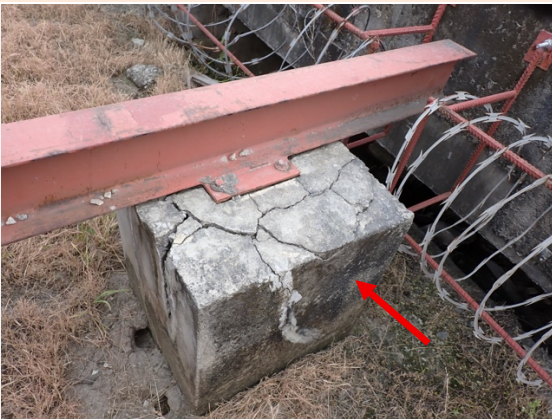
Some damage evident to concrete blocks, installed at the supports – PS31-PS43. Severe damage noted at two supports: PS35 (photo 16) and PS40 (photo 18). Repair required urgently.

Photo: 16  
Comment: PS35 – severe damage to the concrete foundation - B. Repair required

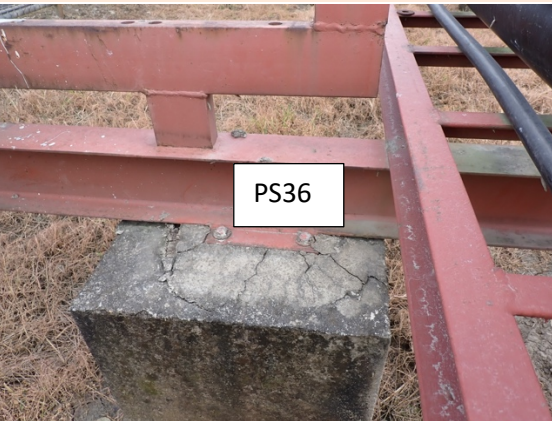
Photo: 17  
Comment: PS36 – Concrete foundation, cracks around the base plate

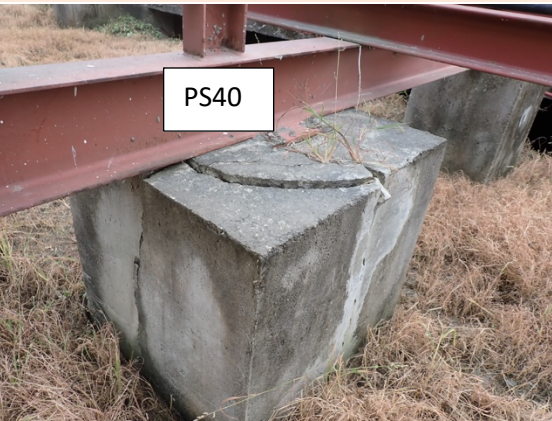
Photo: 18  
Comment: PS40 – severe damage to the concrete foundation. Repair required

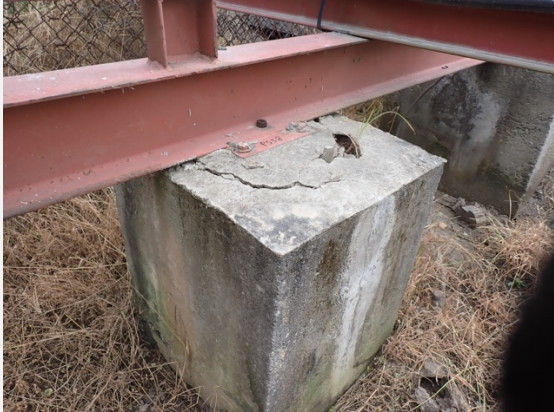
Photo: 19  
Comment: PS43 – Concrete foundation, cracks around the base plate

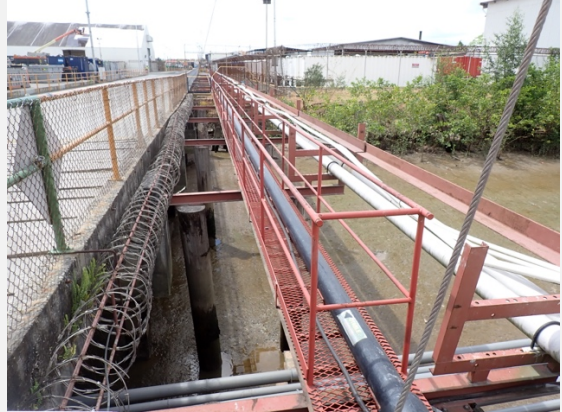
Photo: 20  
Comment: General view of the wooden supports P44 – P49. Each support with two wooden pillars: A and B

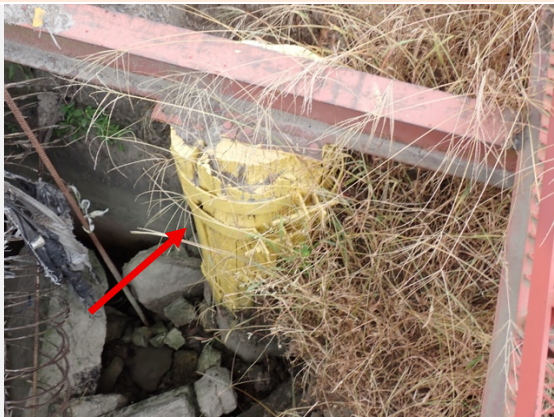
Photo: 21  
Comment: PS44 – Wooden pillar, braced with metal clamps, visible cracks

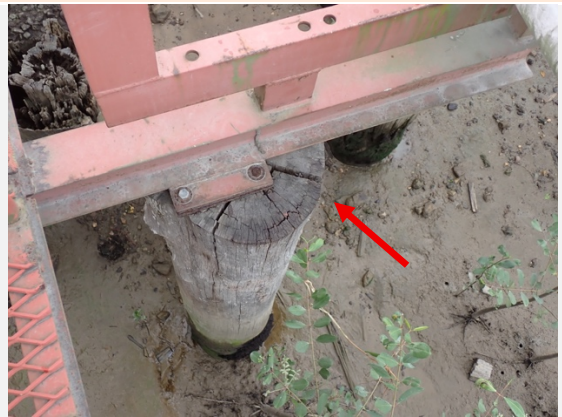
Photo: 22  
Comment: PS45 – Wooden pillar -A, with significant cracking along the top grain visible, some oxidation and rust visible on the fasteners.

There are wooden pillars installed at supports PS44 – PS49. Severe cracking at the top grain visible at most of the pillars, see photos 20-30. Repair with steel bracing, or replacement required. Misalignment between the steel brackets and top of the pillars, resulting in missing fasteners, see photos 24, 29-32. Re-alignment required.

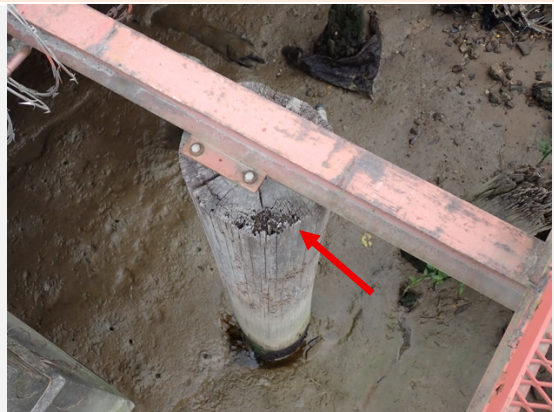
Photo: 23  
Comment: PS45 - Wooden pillar - B, with significant cracking along the top grain visible

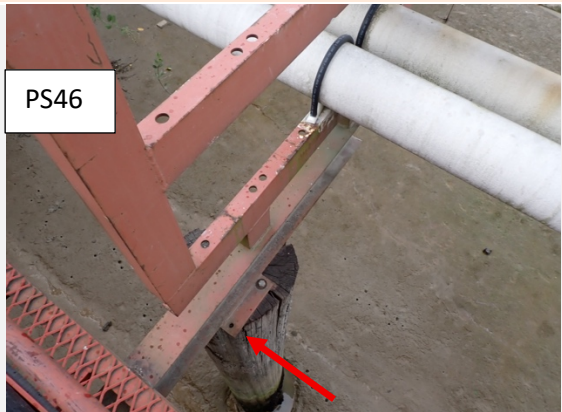
Photo: 24  
Comment: PS46 – The bracket not centered over the pillar A-missing one, out of 4 fixing bolts

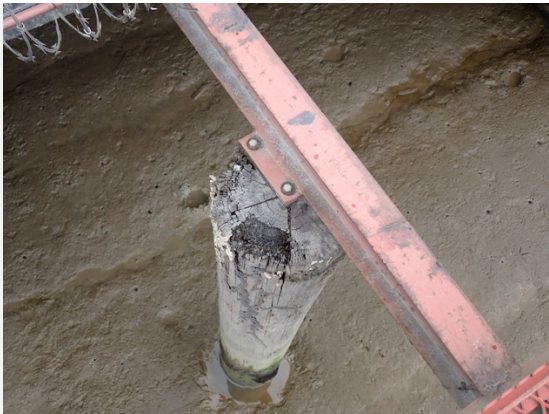
Photo: 25  
Comment: PS46 – Wooden pillar - B, with significant cracking along the top grain visible.

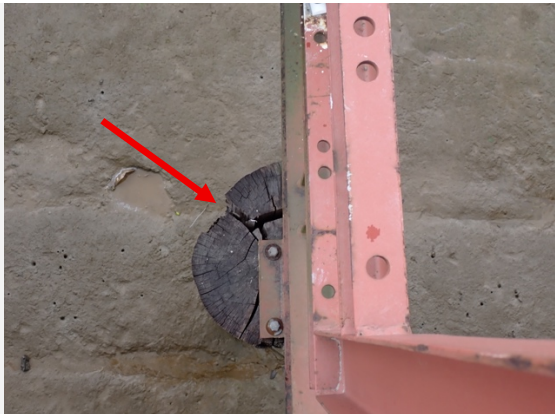
Photo: 26  
Comment: PS46 – Wooden pillar - A, with significant cracking along the top grain visible. The bracket not centered over the pillar -missing one, out of 4 fixing bolts

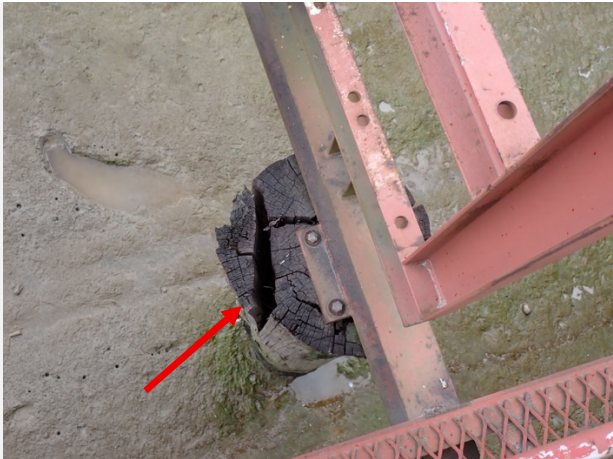
Photo: 27  
Comment: PS47 – Wooden pillar - A, with significant cracking along the top grain visible

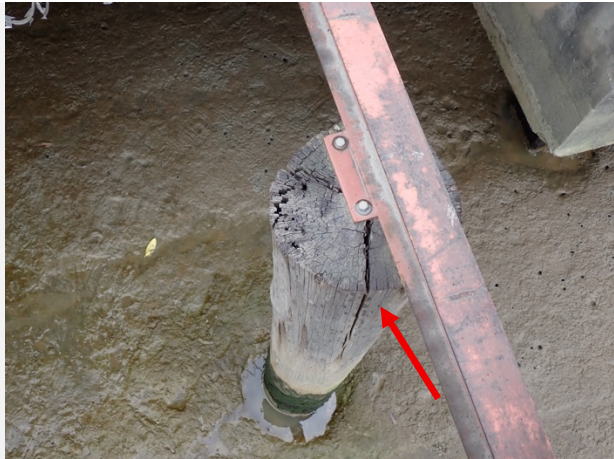
Photo: 28  
Comment: PS47 – Wooden pillar - B, with significant cracking along the top grain visible

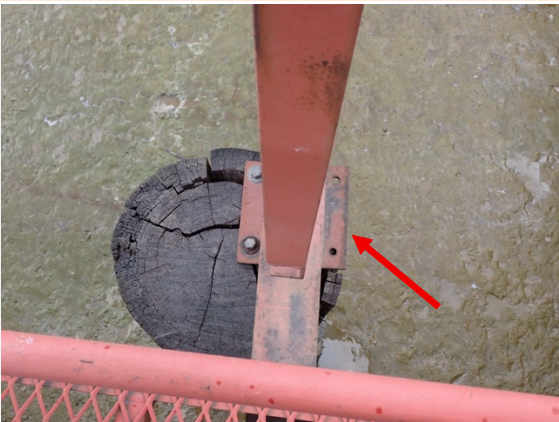
Photo: 29  
Comment: PS48 – Wooden pillar - A, with significant cracking along the top grain visible. The bracket not centered over the pillar -missing two, out of 4 fixing bolts

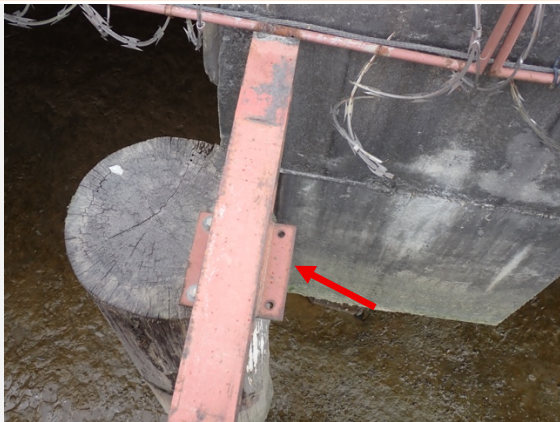
Photo: 30  
Comment: PS48 – Wooden pillar - B. The bracket not centered over the pillar -missing two, out of 4 fixing bolts

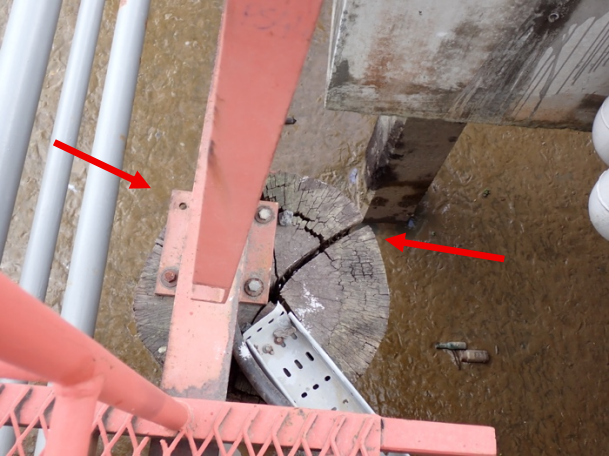
Photo: 31  
Comment: PS49 – Wooden pillar - A, with significant cracking along the top grain visible. The bracket not centered over the pillar -missing one, out of 4 fixing bolts

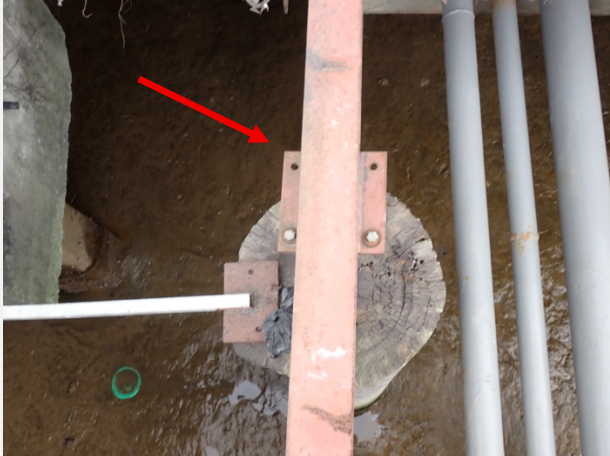
Photo: 32  
Comment: PS49 – Wooden pillar - B. The bracket not centered over the pillar -missing two, out of 4 fixing bolts

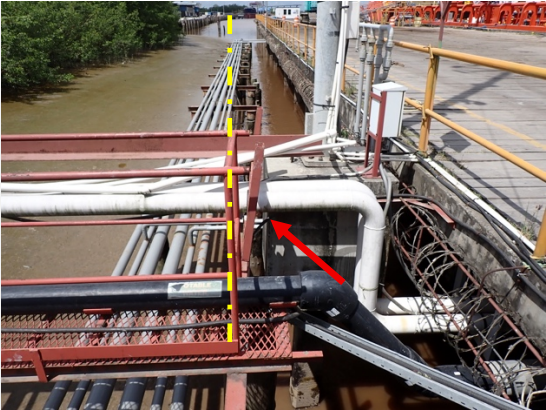
Photo: 33  
Comment: PS49 – support frame bend to the side

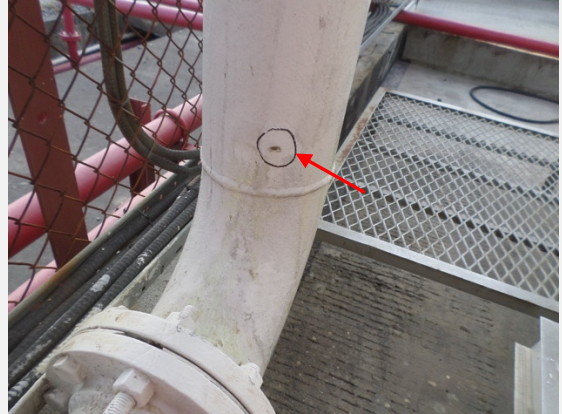
Photo:2  
Comment: Isolated coating damage to the line, location no.9 on ISO

Isolated, minor coating damage areas were noted along the entire line. Touch-up is required to prevent further degradation. See photos below for exact locations.

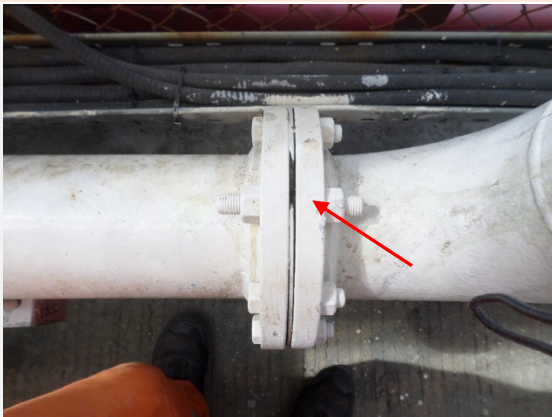
Photo:3  
Comment: Damaged flange gasket at 12 o'clock. Second flange on the line, point no 12 on ISO. No leak present. Reported to the Fuel Pump skid supervisor.

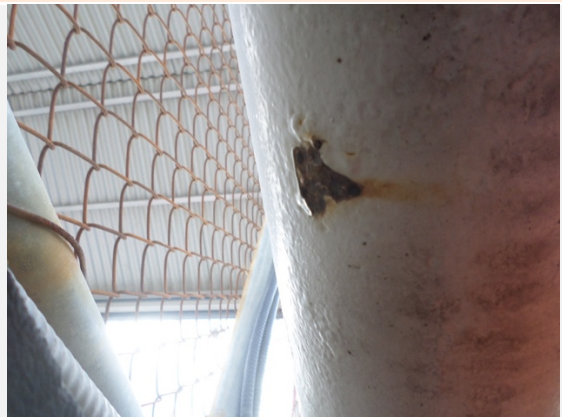
Photo:4  
Comment: Isolated coating damage with surface corrosion 30mm Dia, located at 5 o'clock, location: between pipe supports PS1 and PS12

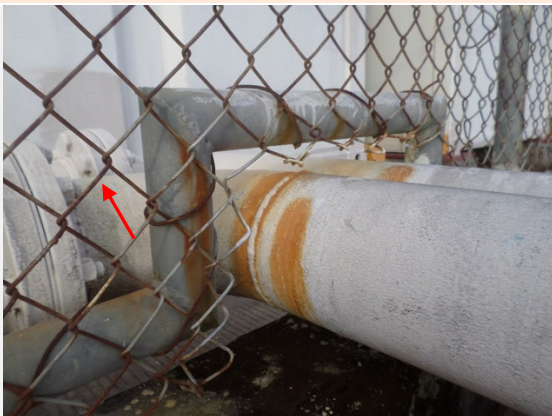
Photo:5  
Comment: Staining, from the metal fencing, noted at the location no 23. No damage to coating noted yet.

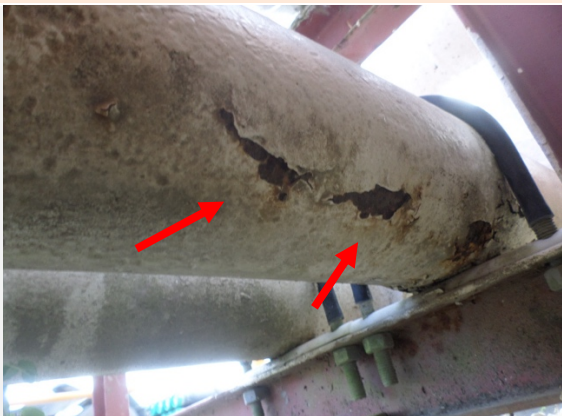
Photo:6  
Comment: Isolated coating damage with surface corrosion, located at 7 o'clock, location: downstream of PS4

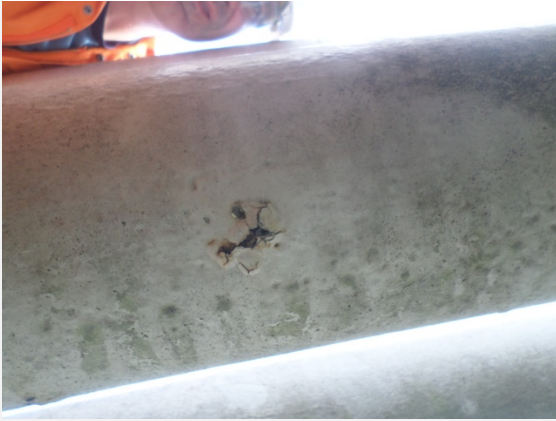
Photo: 7  
Comment: Isolated, corrosion blister at 6 o'clock, location: at point 32, between supports PS4 and PS5

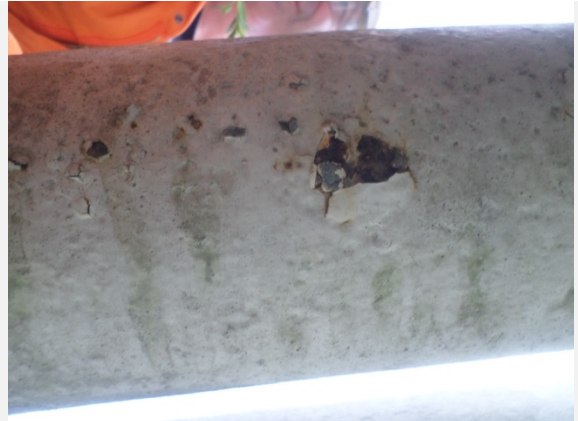
Photo: 8  
Comment: Isolated, corrosion blister at 6 o'clock, location: at point 32, between supports PS4 and PS5

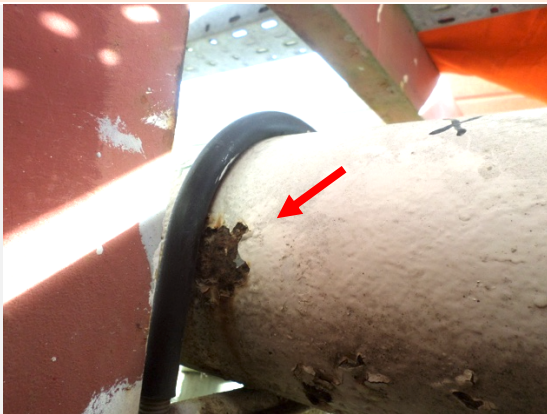
Photo: 9  
Comment: Isolated coating damage with surface corrosion, located at 9 o'clock, at PS5

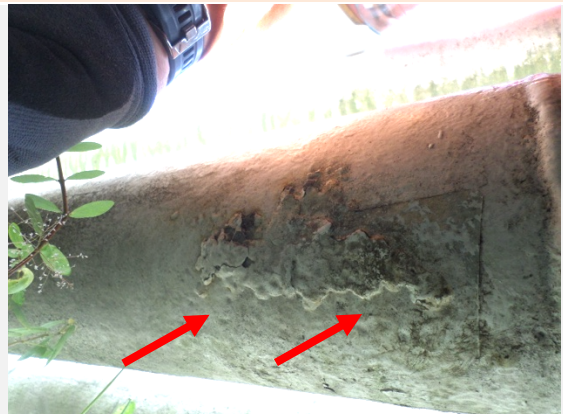
Photo: 10  
Comment: Isolated, corrosion blister at 6 o'clock, located at points 33&34 on ISO

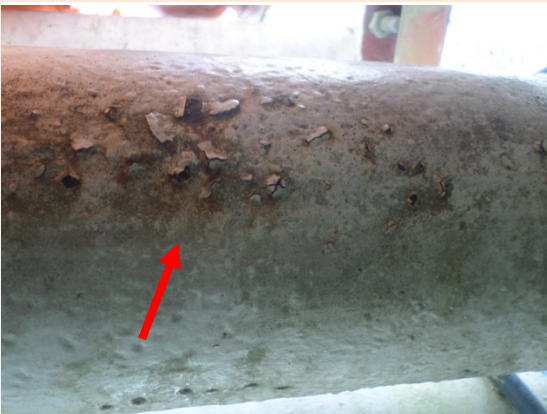
Photo: 11  
Comment: Isolated, corrosion blister at 6 o'clock, located at points 33&34 on ISO

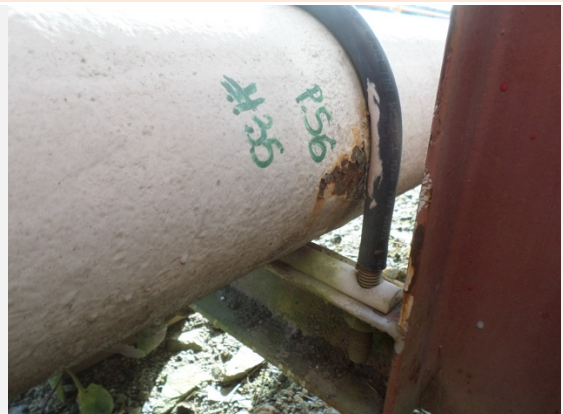
Photo: 12  
Comment: Isolated coating damage with surface corrosion, located at 9 o'clock, at PS6

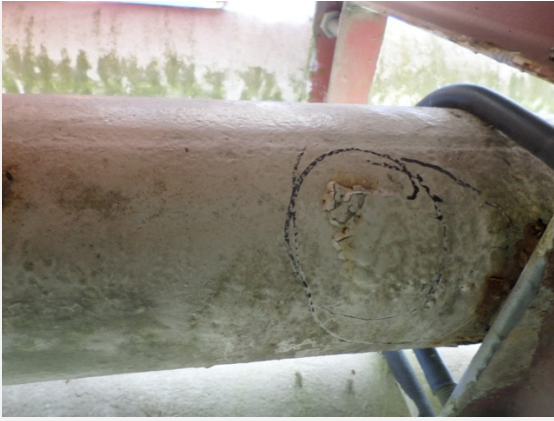
Photo: 13  
Comment: Isolated, corrosion blister at 6 o'clock, location: at pipe support PS8.

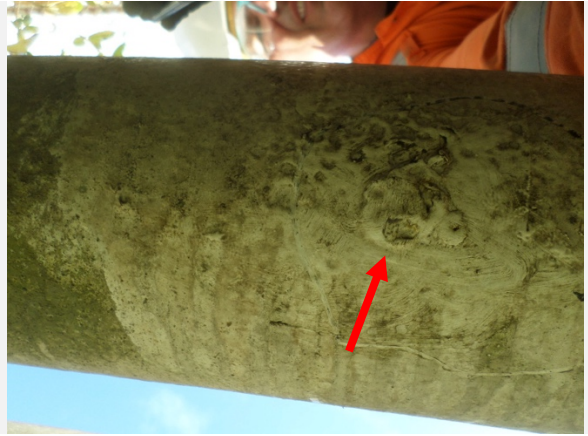
Photo: 14  
Comment: Isolated, corrosion blister at 6 o'clock, location: at point 41, between supports PS8 and PS9

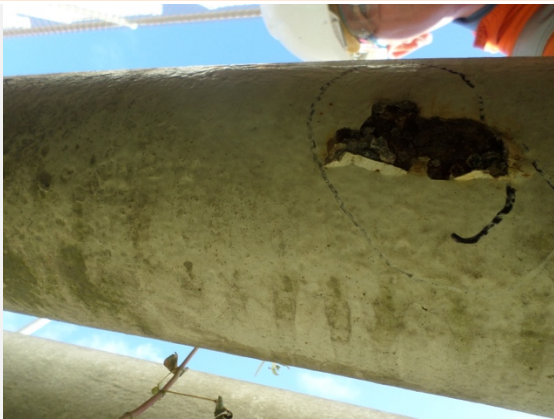
Photo: 15  
Comment: Isolated, corrosion blister at 6 o'clock, location: at point 41, between supports PS8 and PS9

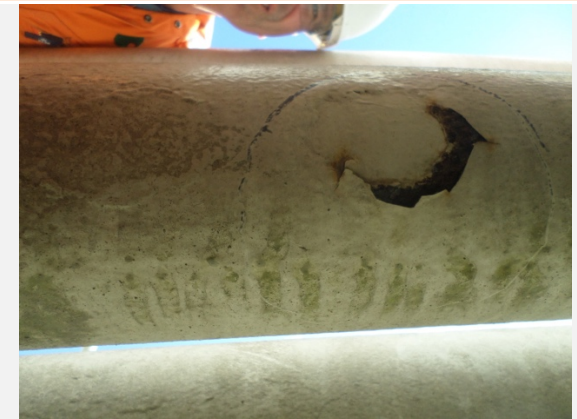
Photo: 16  
Comment: Isolated, corrosion blister at 6 o'clock, location: at point 44, between supports PS9 and PS10

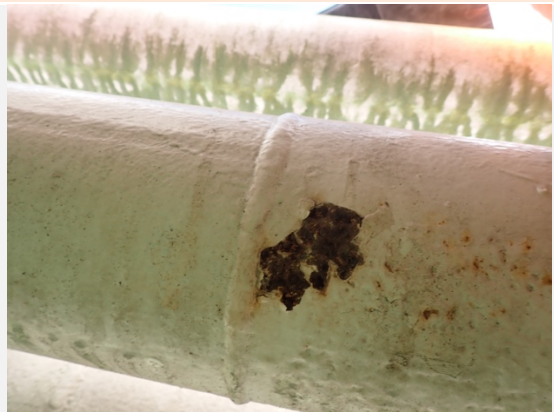
Photo: 17  
Comment: Isolated coating damage with surface corrosion, located at 6 o'clock, at P45,46, between PS10 and PS11

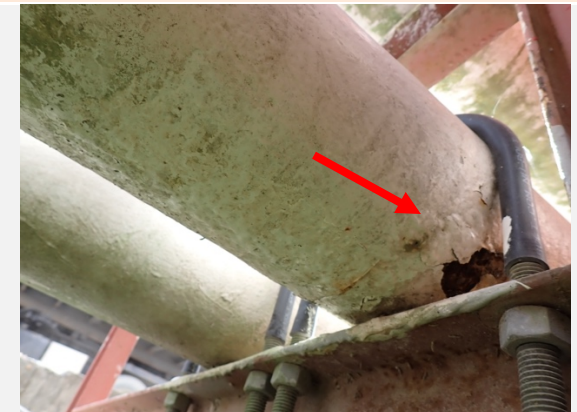
Photo: 18  
Comment: Crevice corrosion present at piping, at 6 o'clock location, at pipe support PS 10.

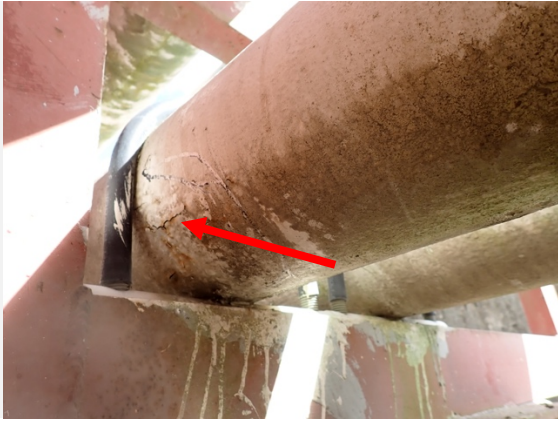
Photo: 19  
Comment: Isolated, corrosion blister at 7 o'clock, location: at support PS12

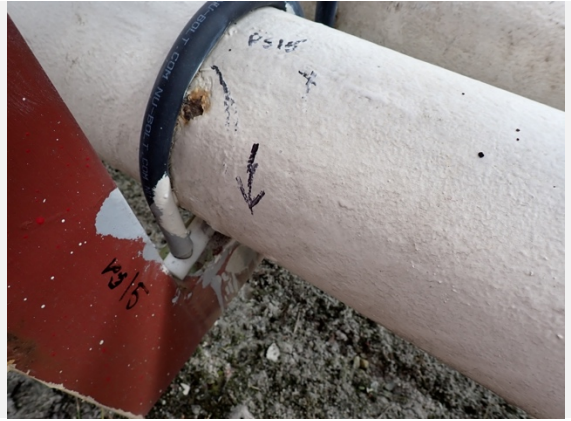
Photo: 20  
Comment: Isolated coating damage with surface corrosion at 11 o'clock, location: at support PS15

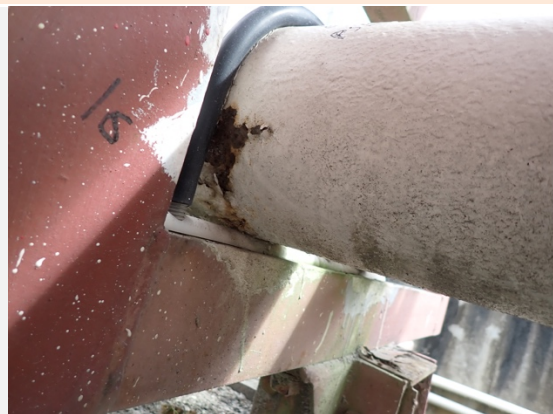
Photo: 21  
Comment: Isolated coating damage with surface corrosion at 9 o'clock, location: at support PS16

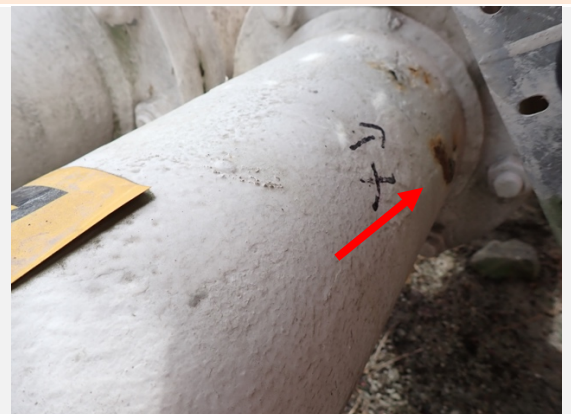
Photo: 22  
Comment: Isolated coating damage with surface corrosion, located at 9 o'clock, at P78, downstream of flange, between PS17 and PS18

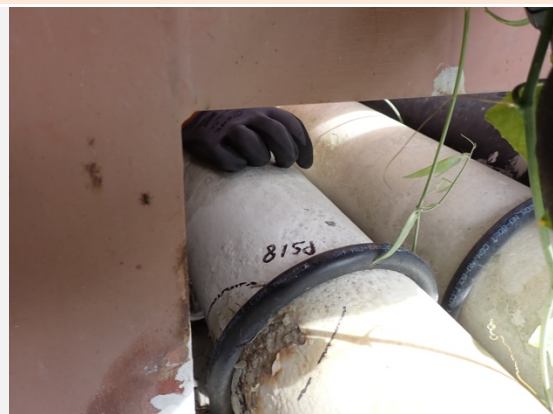
Photo: 23  
Comment: Isolated, corrosion blister at 10 o'clock, location: at support PS18

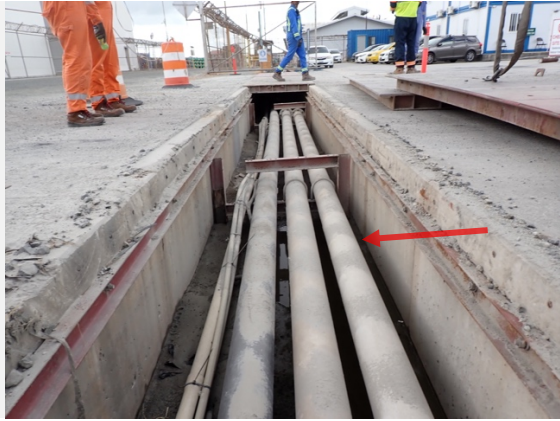
Photo: 25  
Comment: General view of the line, normally located underneath the steel bridge. Good condition

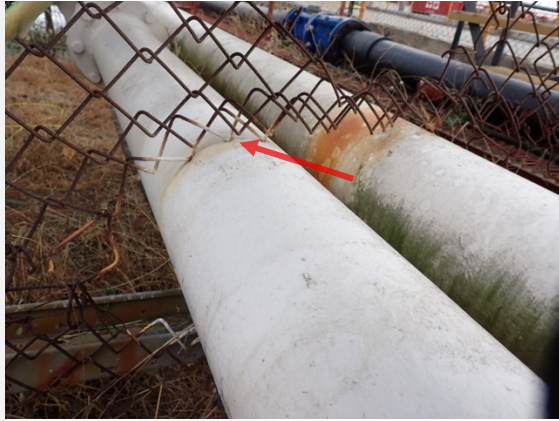
Photo: 26  
Comment: Metal-to-metal contact with the fence, location: downstream of pipe support PS43

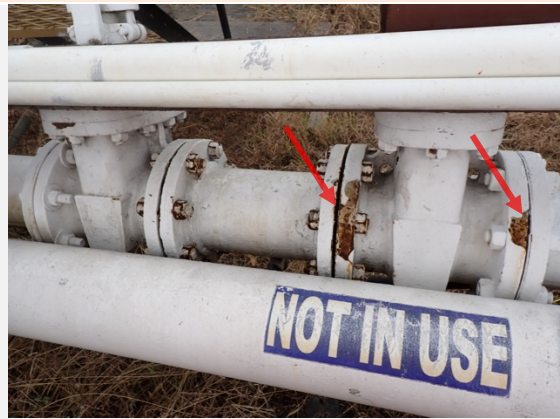
Photo: 27  
Comment: coating damage and surface corrosion on the valve flange, some rusting on the fasteners. Location: point 171
