| | <b>API 570 Inspection on a 6" pipeline</b> | |
| <b>Project Name:</b><br>Fuel line inspection (Sol to Gysbi) | <b>Client Name.:</b><br>Guyana Shore Base Inc. (GYSBI) | <b>Equipment/Tag#:</b><br>Fuel line – Sol to Gysbi |

## API 570 Inspection on a 6" piping Fuel line (Sol to Gysbi)

**DATE OF INSPECTION** : 23 July 2026  
**LOCATION** : Guyana Shore Base (Gysbi)  
**EQUIPMENT** : Fuel line (Sol to Gysbi)  
**JOB NO** : 5831

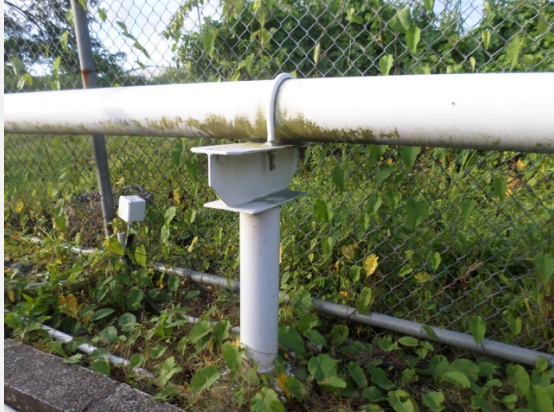
Photo: 1  
Comment: Pipe support PS3 – typical condition, generally good, of the supports (except for the supports reported below) on the line.

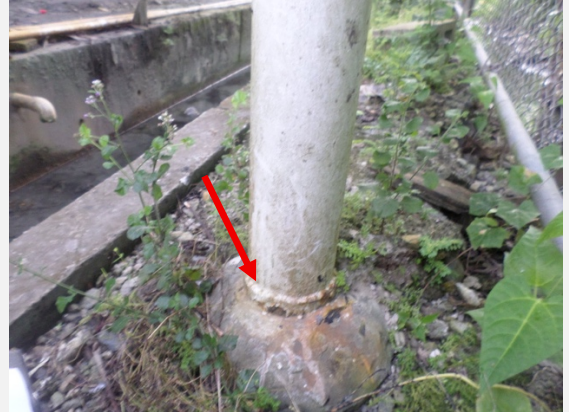
Photo: 2  
Comment: Pipe support foundation, at PS7 found with surface corrosion at the foundation.

Base support found corroded at the following supports: PS7, PS9 and PS19, fabric maintenance recommended

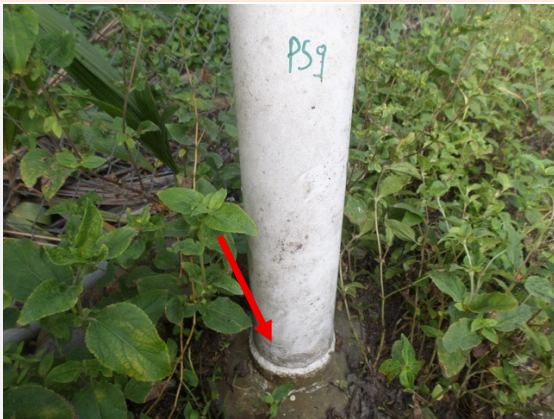
Photo: 3  
Comment: Pipe support foundation, at PS9 found with surface corrosion at the foundation.

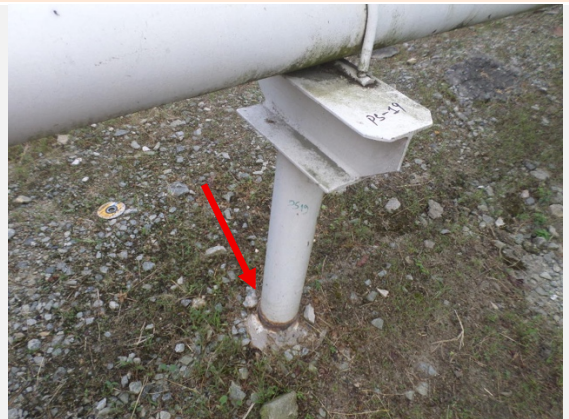
Photo: 4  
Comment: Pipe support foundation, at PS19 found with corrosion at the foundation.

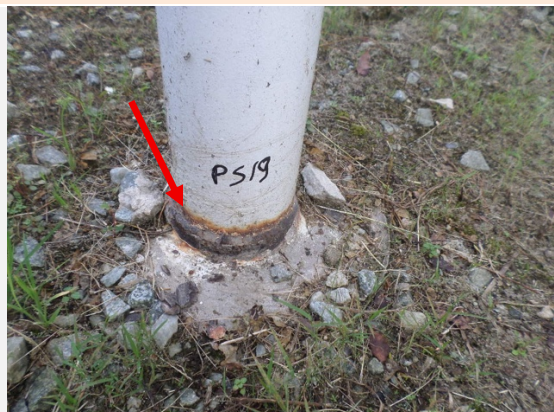
Photo: 5  
Comment: Pipe support foundation, at PS19 found with corrosion at the foundation.

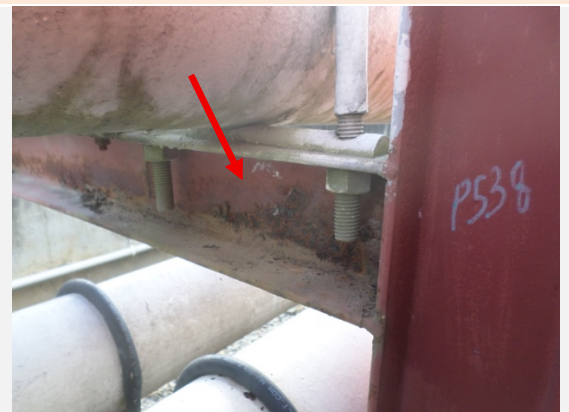
Photo: 6  
Comment: Coating breakdown and surface corrosion at the U-beam at support PS38

Coating breakdowns and surface corrosion noted at PS38, PS39, PS55, PS56, PS57, PS58, PS59 and PS60. Fabric maintenance recommended.

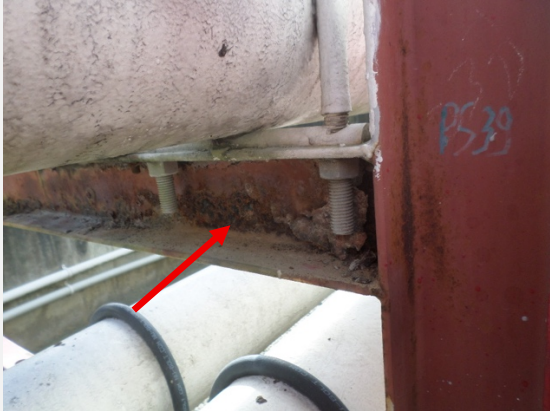
Photo: 7  
Comment: Coating breakdown and surface corrosion at the U-beam at support PS39

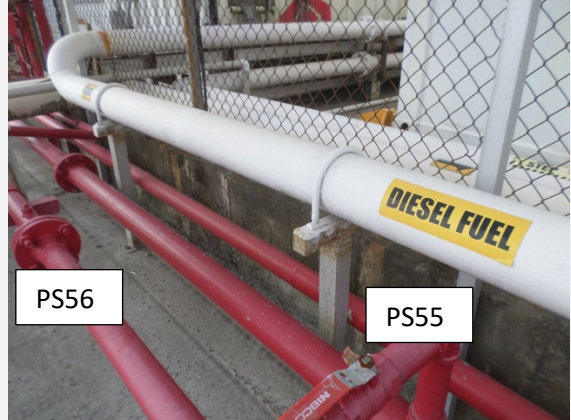
Photo: 8  
Comment: Standout view of the two supports -PS55 and PS56

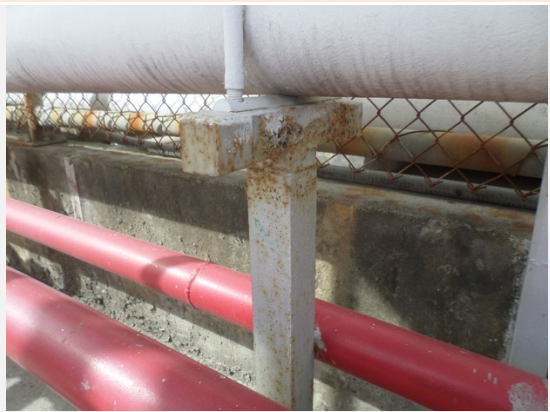
Photo: 9  
Comment: PS55 – Coating breakdown and surface corrosion on the beam support

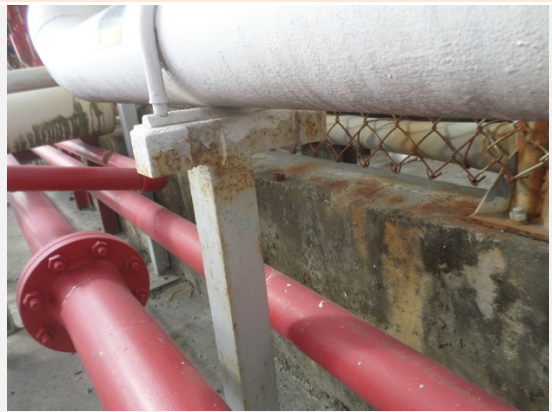
Photo: 10  
Comment: PS56 – Coating breakdown and surface corrosion on the beam support

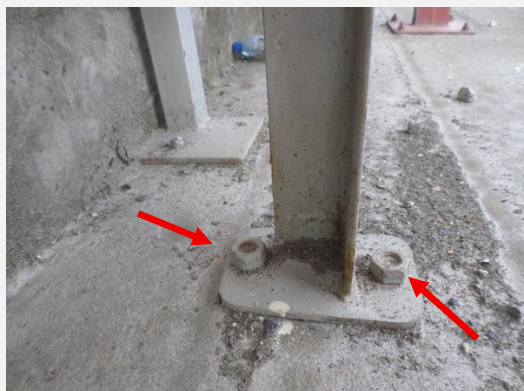
Insufficient thread engagement at the fasteners, at the base of the supports, PS55 and PS56 (photos 11&12), in addition, the air gap between the nut and the joint surface noted, at the base of the support PS56 (photo 12). Re-tightening required, replacement if not successful.

Photo: 11  
Comment: PS55 – Insufficient thread engagement at the fasteners, at the base of the support

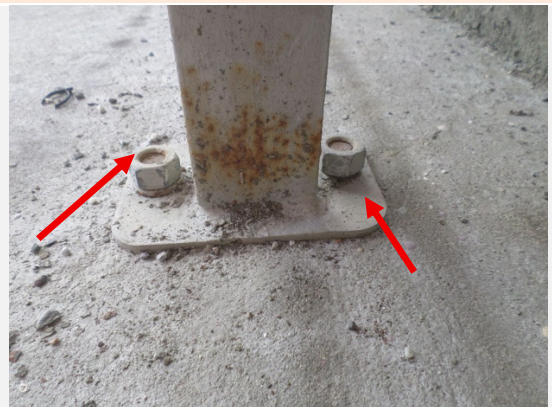
Photo: 12  
Comment: PS56 – Insufficient thread engagement and the air gap between the nut and the joint surface, at the base of the support

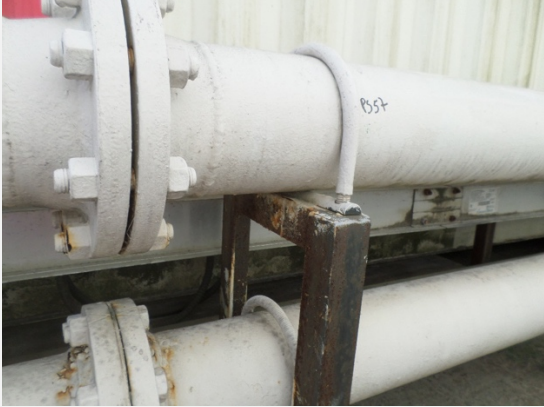
**Photo: 13**  
Comment: PS57 - Coating breakdown and surface corrosion on the beam support

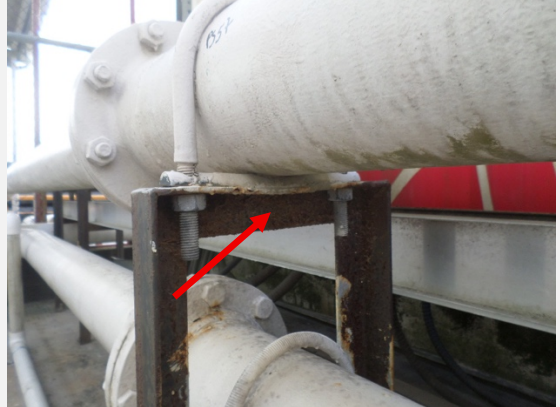
L-profile beam, at PS57 found bent (photo 14), no change in condition since last inspection. To be monitored.

**Photo: 14**  
Comment: L-profile beam PS57 found with localized surface corrosion at inner side of beam and found bent, No change in condition since last inspection

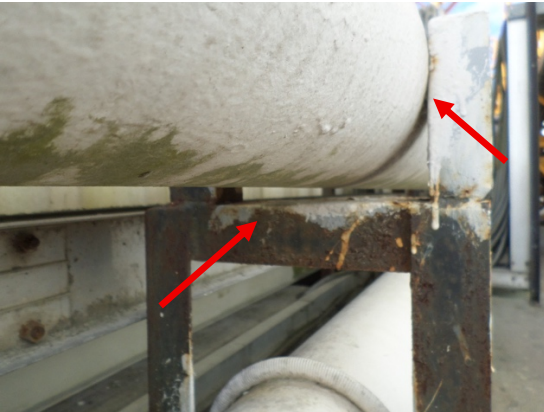
**Photo: 15**  
Comment: PS58 – Direct contact, “metal to metal”, between pipe and the guide, air gap of 12mm between the pipe and the support. Coating damage and surface corrosion noted on the guide support

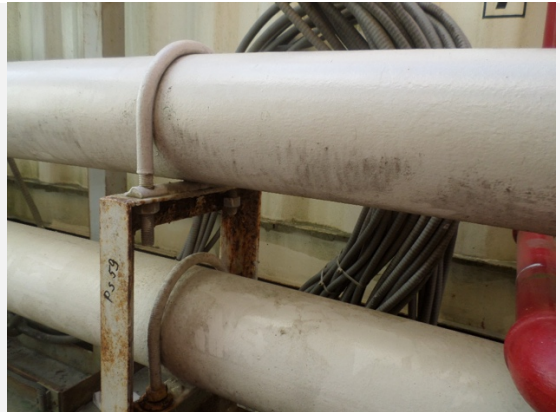
**Photo: 16**  
Comment: PS59 - Coating breakdown and surface corrosion on the support

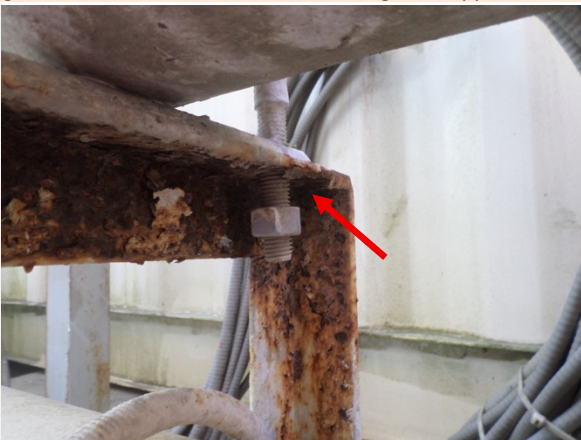
U-bolt fastener not tightened, stuck in the position, possible thread damage, at PS59 (photo 17). Re-tightening required, U-bolt replacement needed, if repair not successful.

**Photo: 17**  
Comment: PS59 – U-bolt fastener not tightened, stuck in the position, possible thread damage

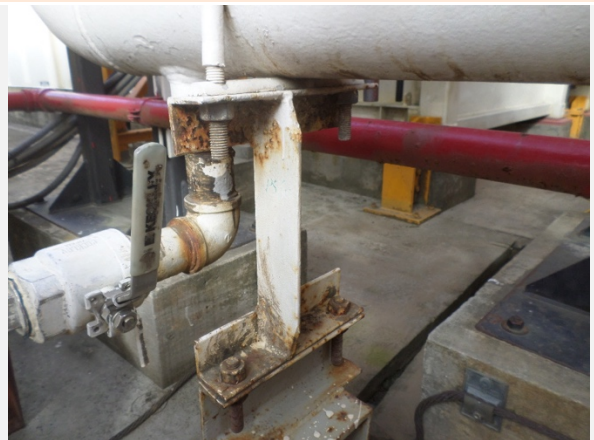
**Photo: 18**  
Comment: PS60 - Coating breakdown and surface corrosion on the support

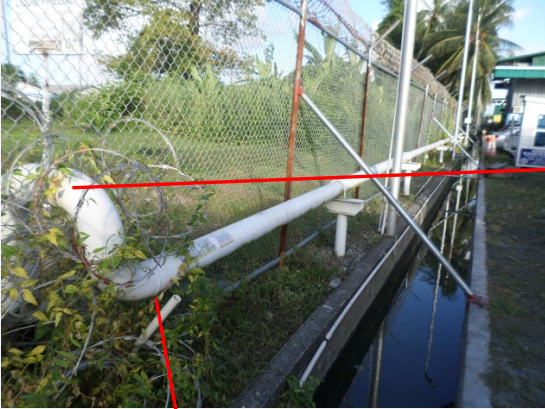
Photo: 1  
Comment: View of the start of the Fuel Diesel line (Sol to Gysbi)

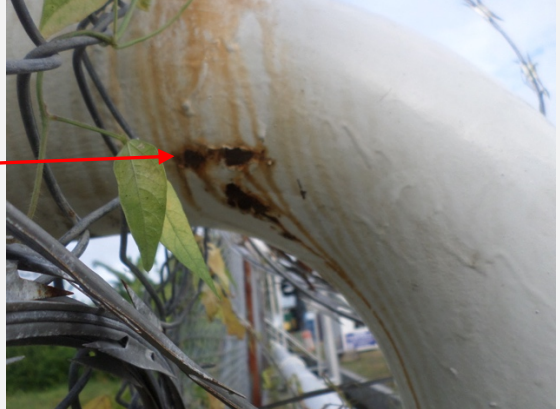
Photo:2  
Comment: Elbow component, location 5 on iso, found with localized corrosion

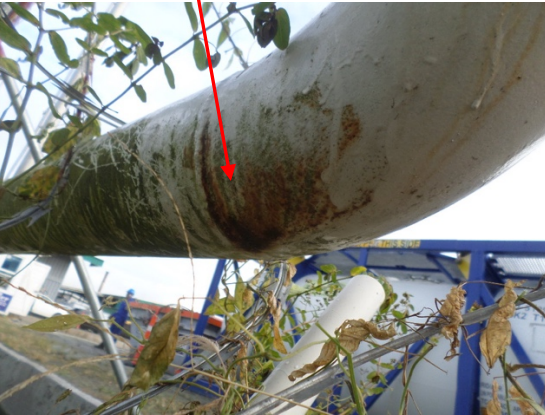
Photo:3  
Comment: Elbow component, location 8 on iso, found with localized corrosion

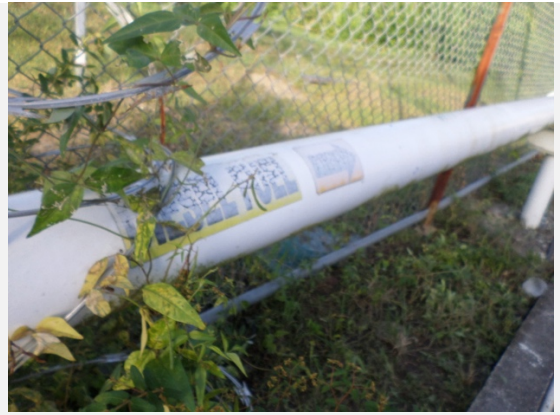
Photo:4  
Comment: Faded stickers (due to UV) at the beginning of the line

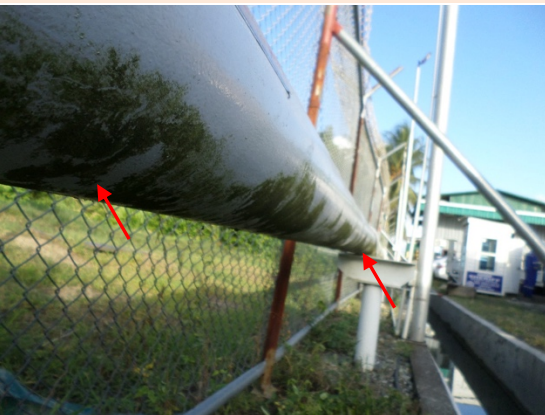
Photo:5  
Comment: Algae present at the 6 o'clock location, typical to the entire line.

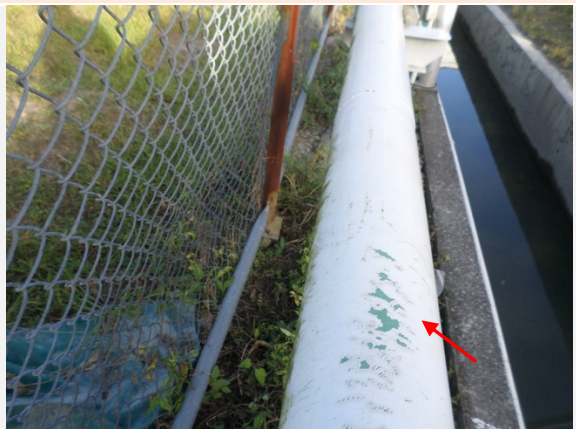
Photo:6  
Comment: Topcoat damage to the section of the line, upstream of Pipe support PS1.

Isolated, minor coating damage areas were noted along the entire line. Touch-up is required to prevent further degradation. See photos below for exact locations.

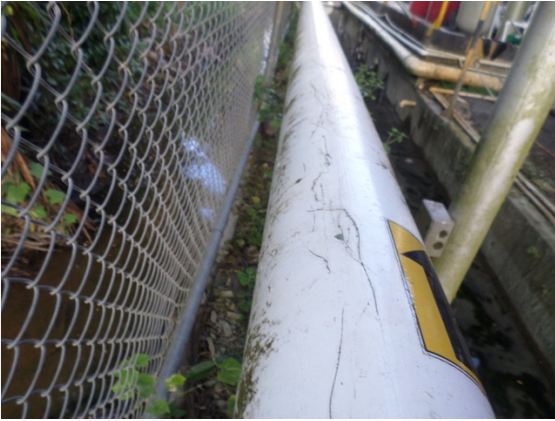
**Photo: 7**  
Comment: Localized, minor, mechanical coating damage located at 12 o'clock, between pipe supports PS6 and PS7.

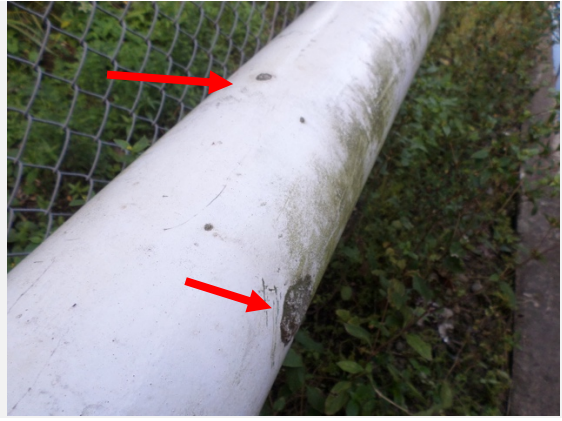
Concrete spatter (presumably, from nearby concrete work) noted at the long section of the line, from the beginning to the line, line running parallel to the fence, until the T-piece (point no 105). See photos 8, 11-15, 19-20, with largest spatter, 150mm x 150mm and 10mm high, see photo 13. Removal of the spatter and FM required, as the surface underneath, may be subject to aggressive corrosion process.

**Photo: 8**  
Comment: Isolated concrete spatter noted at the line, location: between pipe supports PS6 and PS7

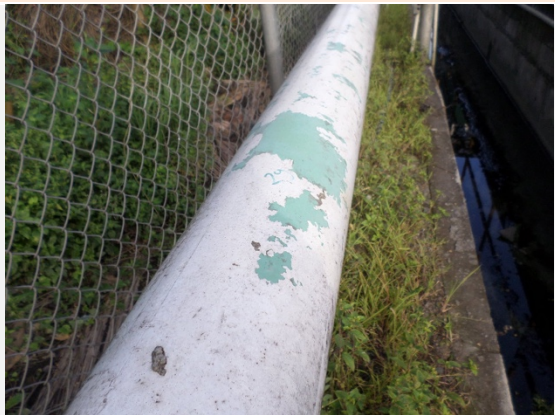
**Photo: 9**  
Comment: Topcoat damage to the section of the line, location: between pipe supports PS9 and PS10

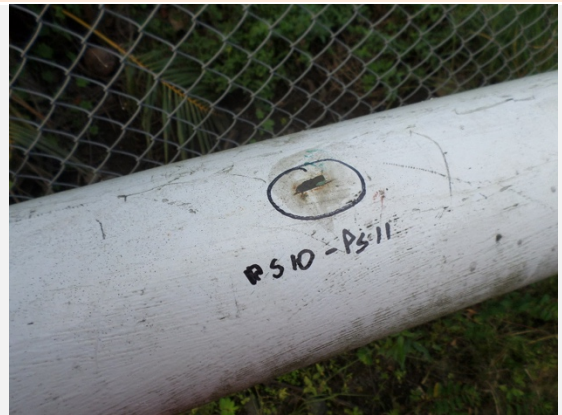
**Photo: 10**  
Comment: Localized corrosion spot (Dia 30mm), surface corrosion at 12 o'clock, location: between pipe supports PS10 and PS11

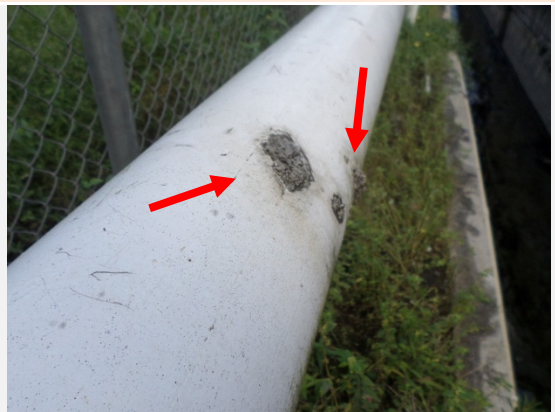
**Photo: 11**  
Comment: Isolated concrete spatter noted at the line, location: between pipe supports PS10 and PS11

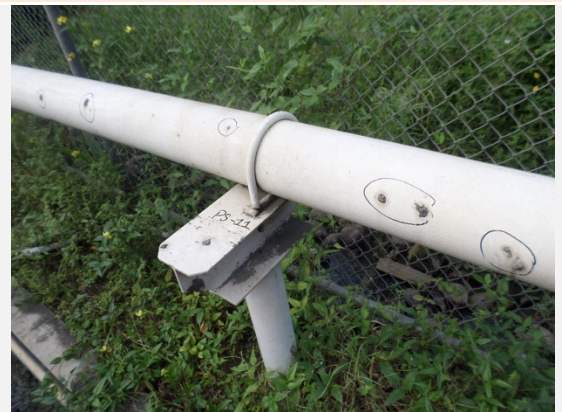
**Photo: 12**  
Comment: Localized concrete spatter located downstream and upstream of pipe support PS11.

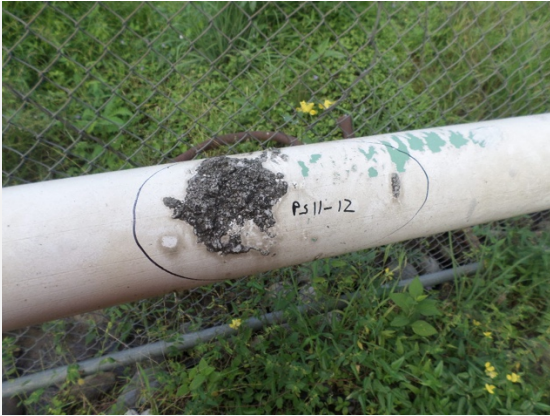
Photo: 13  
Comment: Isolated, large (150mm x 150mm) and 10mm thick, concrete spatter noted at the line, location: between pipe supports P11 and PS12

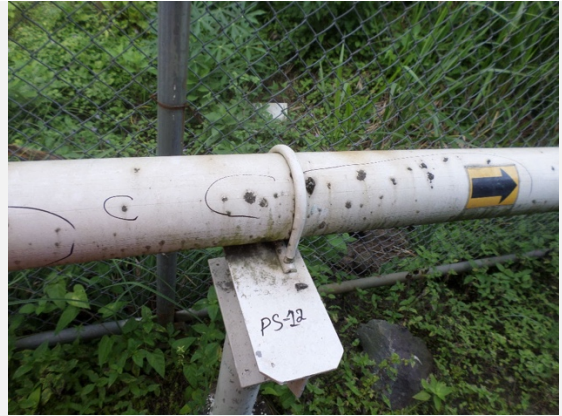
Photo: 14  
Comment: Localized concrete spatter located downstream and upstream of pipe support PS12.

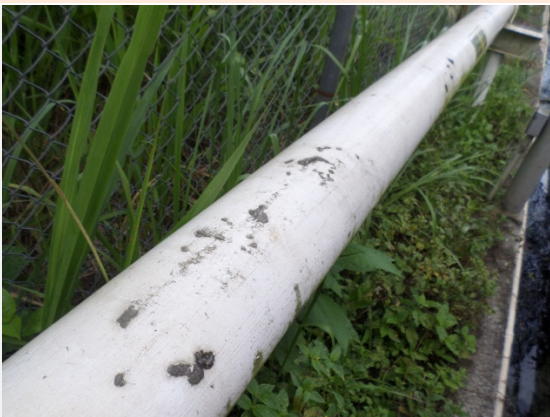
Photo: 15  
Comment: Isolated concrete spatter noted at the line, location: between pipe supports PS12 and PS13

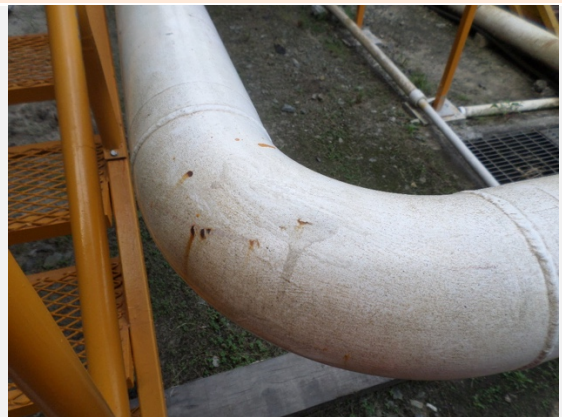
Photo: 16  
Comment: Isolated coating damage and surface corroded spots, at elbow, location no 68

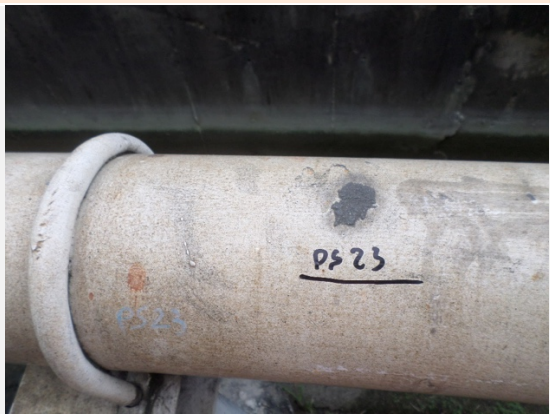
Photo: 17  
Comment: Isolated concrete spatter noted at the line, location: downstream of pipe supports PS23

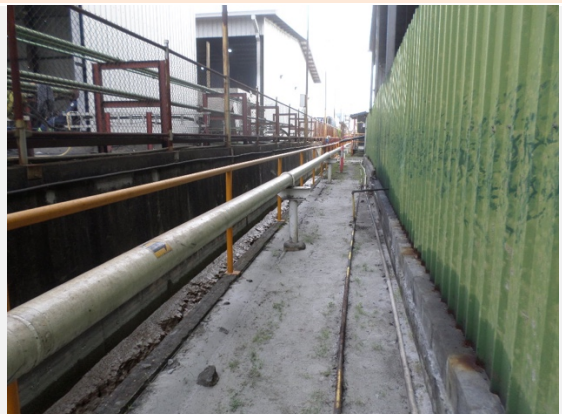
Photo: 18  
Comment: General view of the line, between Pipe supports: PS23 and PS37

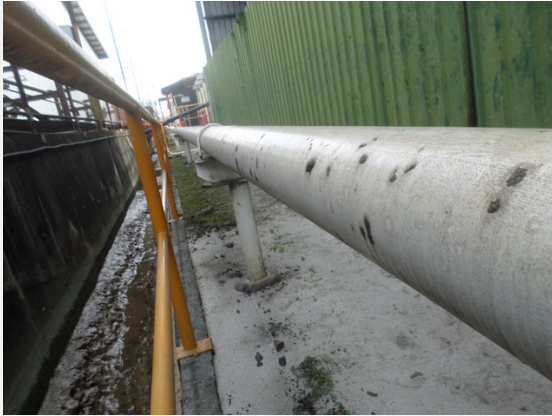
Photo: 19  
Comment: Isolated concrete spatter noted at the line, location: between pipe supports PS26 and PS27

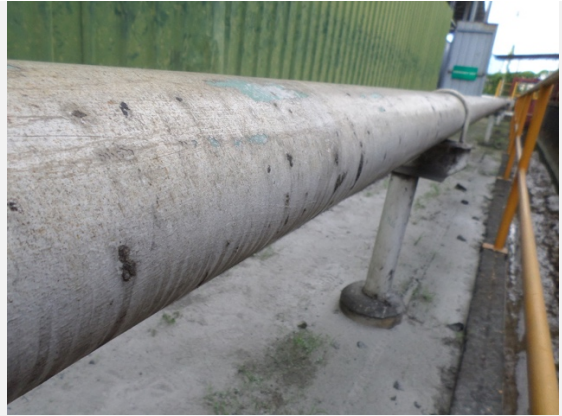
Photo: 20  
Comment: Isolated concrete spatter noted at the line, location: between pipe supports PS26 and PS27

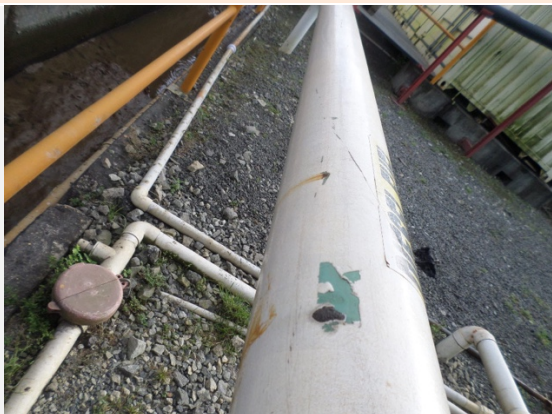
Photo: 21  
Comment: Coating damage and concrete spatter noted at the line, location: between pipe supports PS28 and PS29

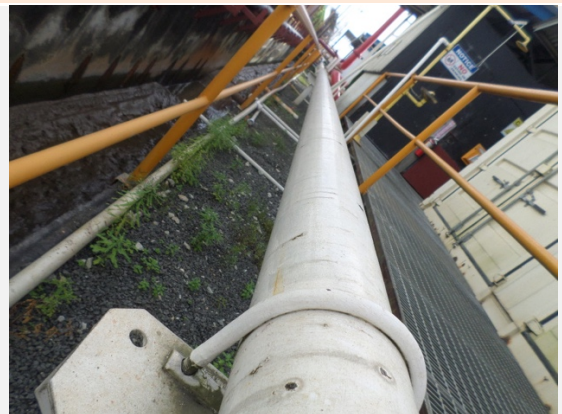
Photo: 22  
Comment: Isolated, minor concrete spatter noted at the long span of the line, location: between pipe supports PS29 and PS32

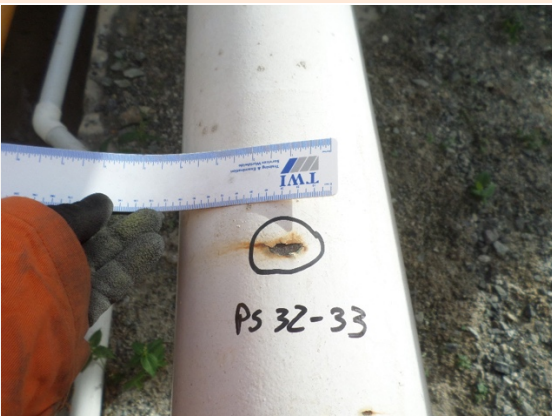
Photo: 23  
Comment: Localized corrosion spot (30mm long), surface corrosion at 12 o'clock, location: between pipe supports PS32 and PS33

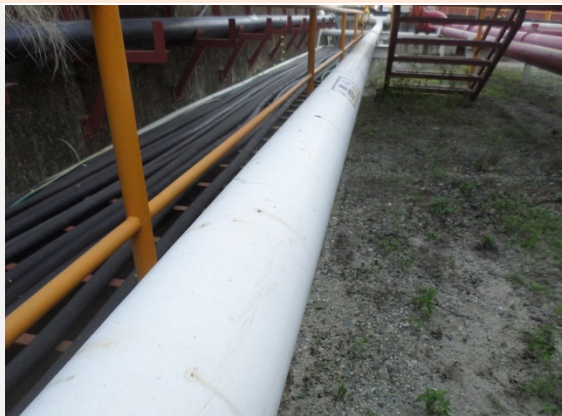
Photo: 24  
Comment: Isolated minor coating breakdowns on the line, location: between pipe supports PS35 and PS36

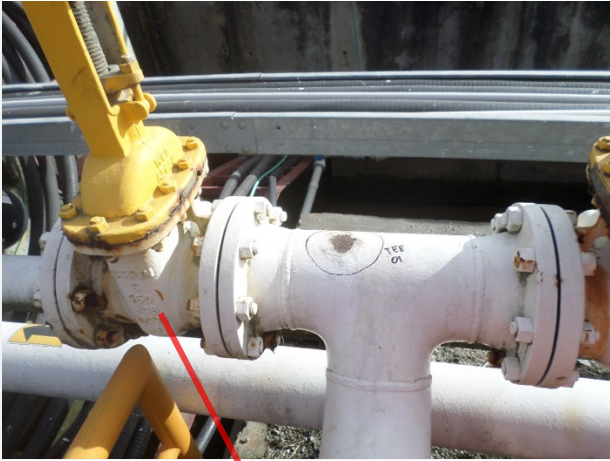
Photo: 25  
Comment: Localized corrosion spot (Dia 65mm), surface corrosion at 12 o'clock, location: T-piece, at location 105

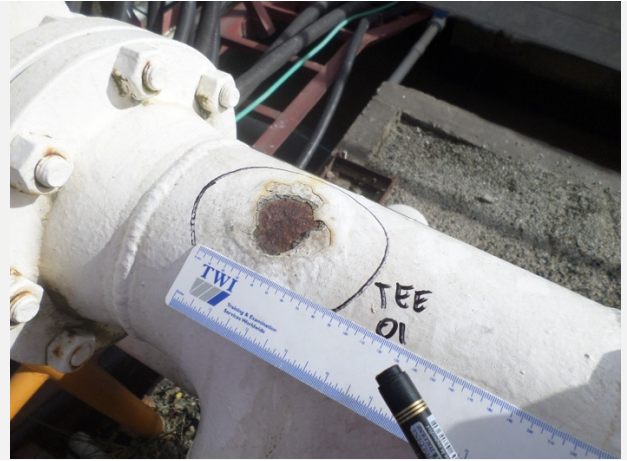
Photo: 26  
Comment: Localized corrosion spot (Dia 65mm), surface corrosion at 12 o'clock, location: T-piece, at location 105

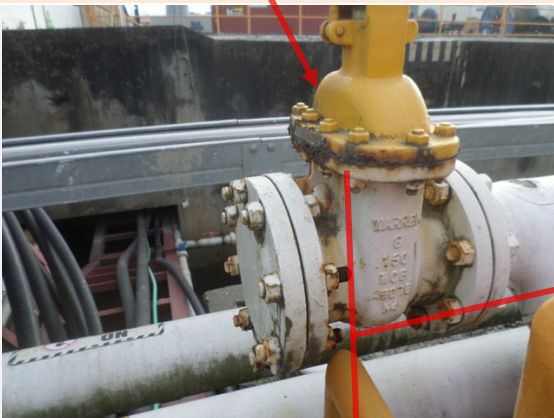
Photo: 27  
Comment: General view of the Gate Valve, corrosion noted at the body and the flange fasteners. Valve upstream of T-Piece.

Minor crevice corrosion noted on the valves, installed on the line, see photos 27-30. Coating repair would be required during next turn-over.

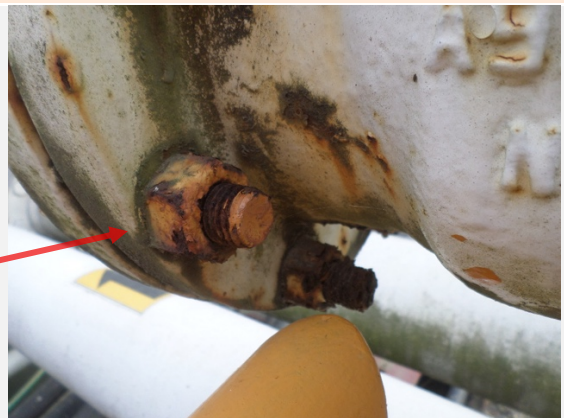
Photo: 28  
Comment: Close-up photo - Surface corrosion noted on the flange fasteners. Valve upstream of T-Piece.

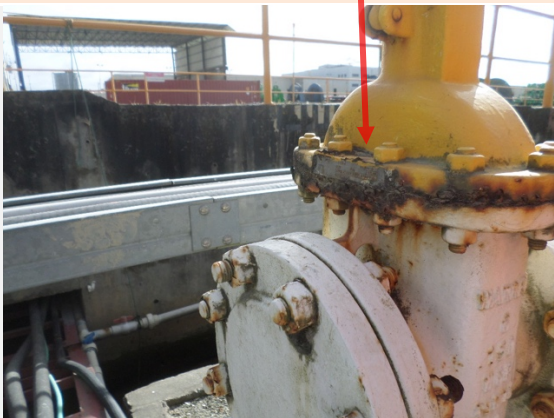
Photo: 29  
Comment: Close-up photo Crevice corrosion noted on the bonnet to body, flanged joint. Valve upstream of T-Piece.

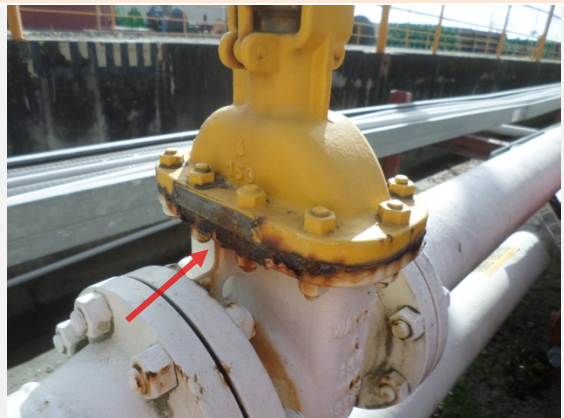
Photo: 30  
Comment: Crevice corrosion noted on the bonnet to body, flanged joint. Valve downstream of T-Piece.

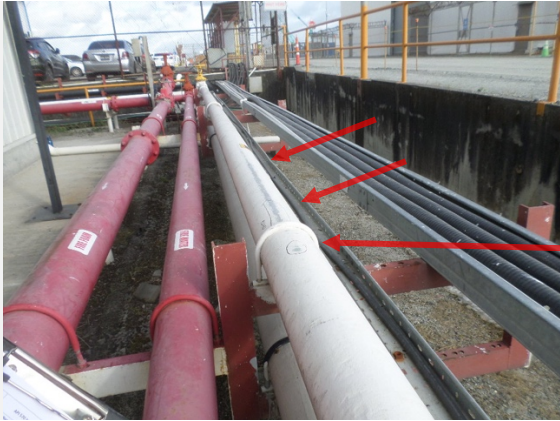
**Photo: 31**  
Comment: Isolated minor coating breakdowns on the line, location: around pipe support PS40

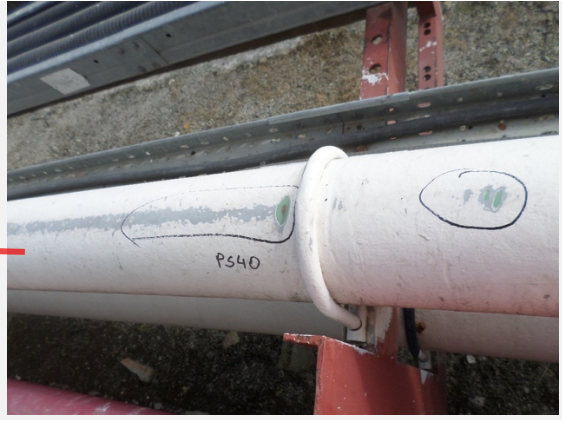
**Photo: 32**  
Comment: Isolated minor coating breakdowns on the line, location: around pipe support PS40

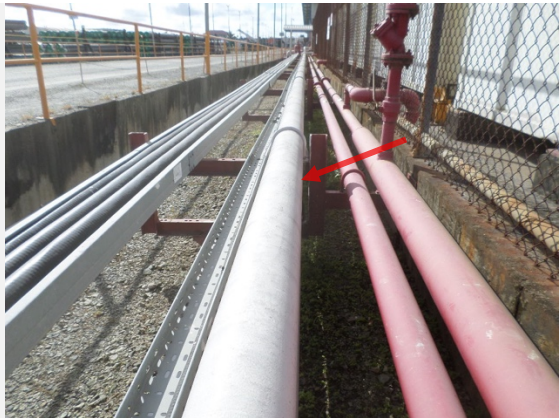
**Photo: 33**  
Comment: General view of the line, between Pipe supports: PS45 and PS50

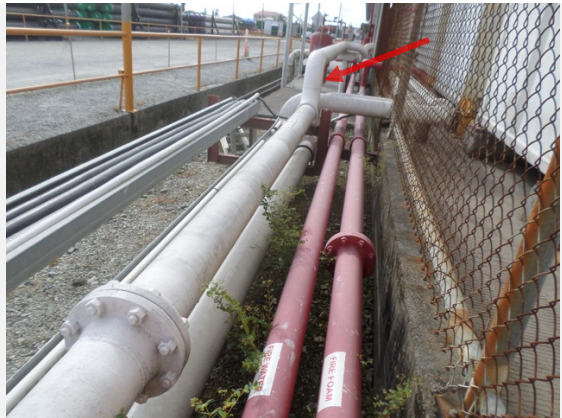
**Photo: 34**  
Comment: General view of the line, between Pipe supports: PS52 and PS54

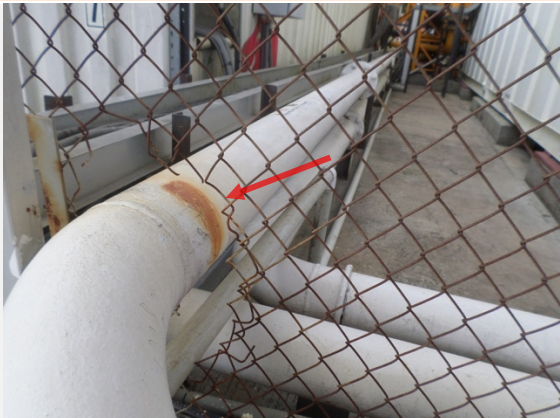
**Photo: 35**  
Comment: Staining, from the metal fencing, noted at the location no 176. No damage to coating noted yet.

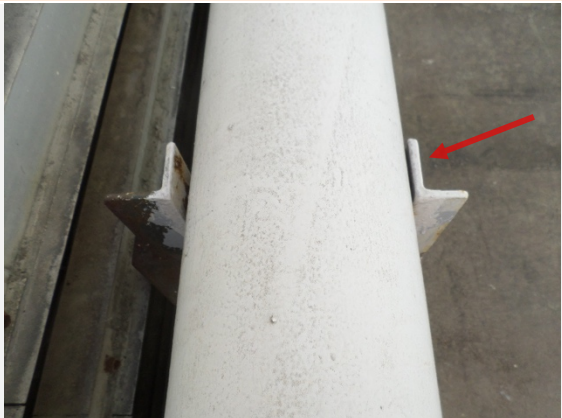
**Photo: 36**  
Comment: Direct contact, "metal to metal", between pipe and the guide, at Pipe support PS58

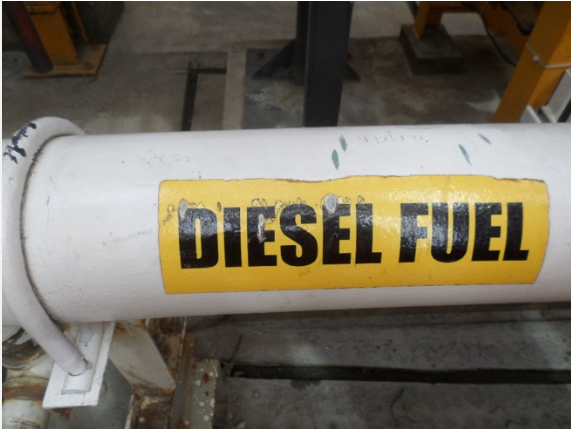
Photo: 37

Comment: Isolated, minor coating breakdowns spots, at 12 o'clock, location, upstream of pipe support PS60

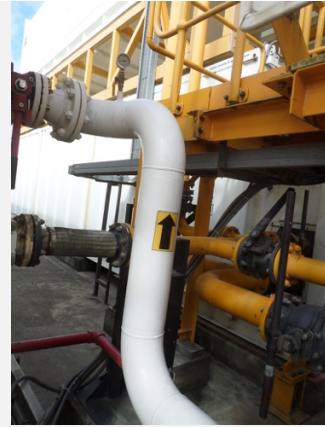
Photo: 38

Comment: General view of the termination of the line.

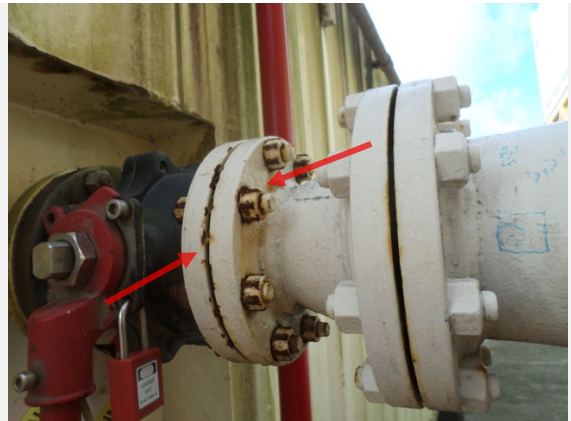
Photo: 39

Comment: Surface corrosion to the flange fasteners at the line termination flange. Minor crevice corrosion noted on the flange-to-flange interface.
