## Ultrasonic testing report

| Report No. | APGY/26/UT/004 | Revision: | 01 |

| Project: | Fuel line under the wharf (Berth 1 & 2) | Procedure number: | T.P.AI.WI.UT.0001 – V1 |

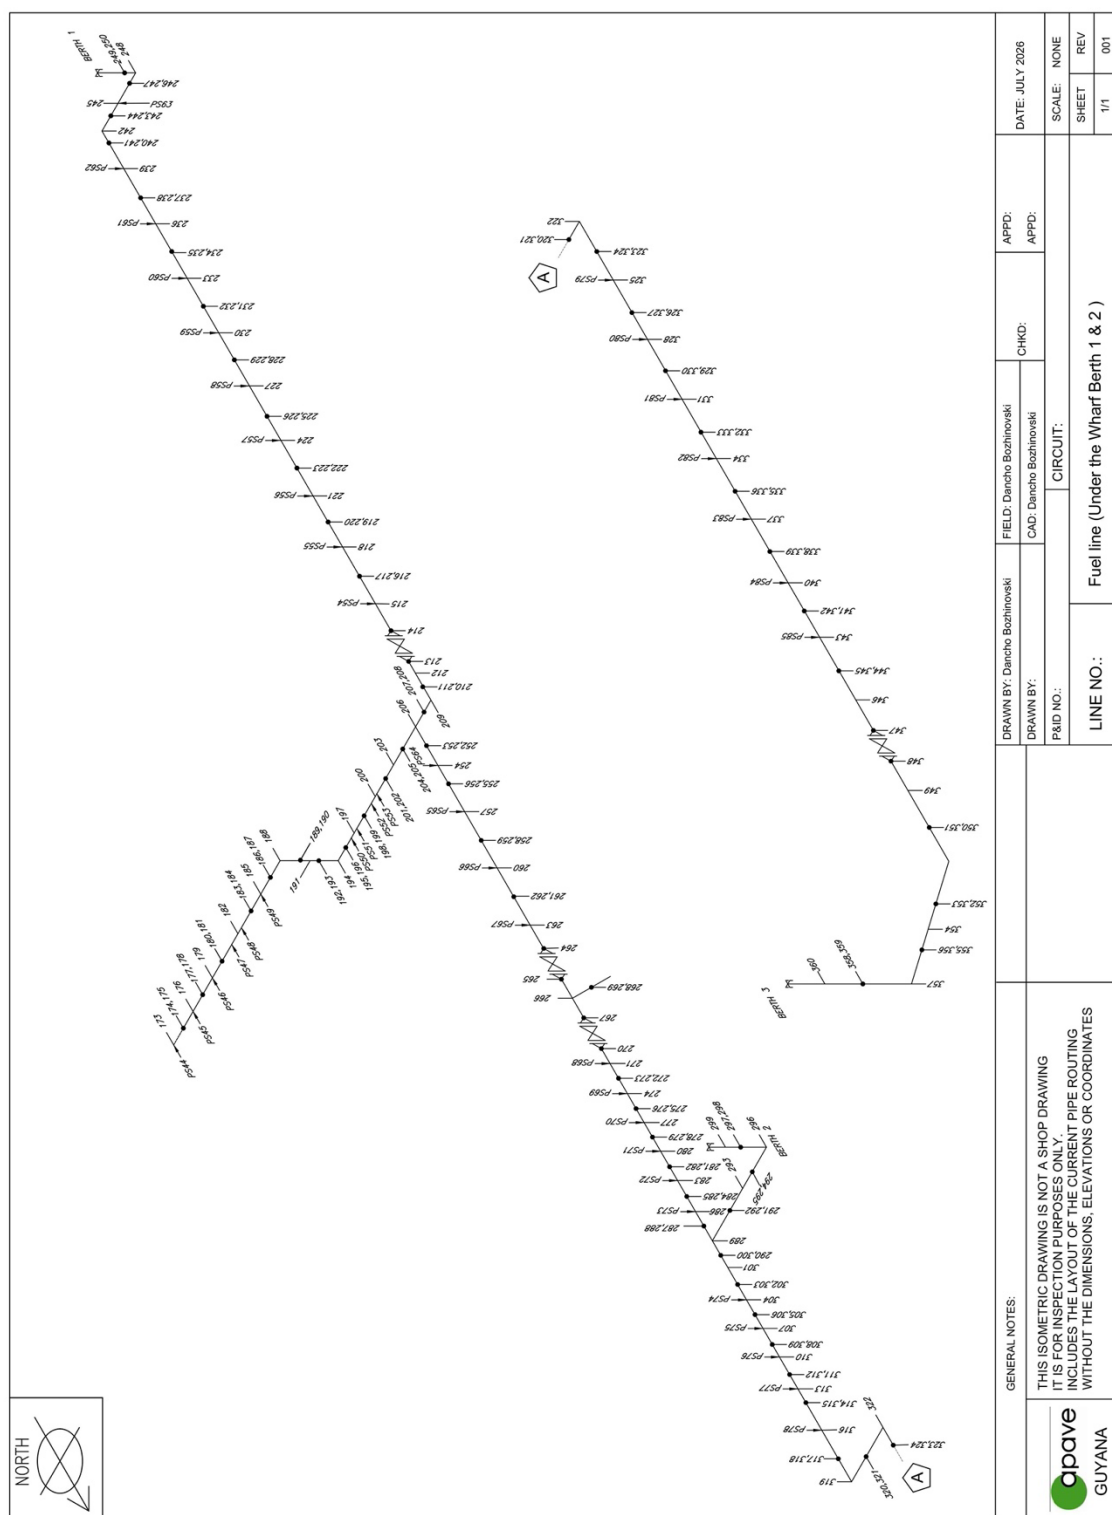
## Drawing / Sketch / ISO

Comment: Isometric Diagram rev.1
