| | <b>API 570 Inspection on a 6" pipeline</b> | |
| <b>Project Name:</b><br>Fuel line inspection (Berths 3 and 4) | <b>Client Name.:</b><br>Guyana Shore Base Inc. (GYSBI) | <b>Equipment/Tag#:</b><br>Fuel line – Berths 3 and 4 |
| | | <b>Report N-r. :</b><br>APGY/2026/API-03 |

**DATE OF INSPECTION** : 31 July 2026

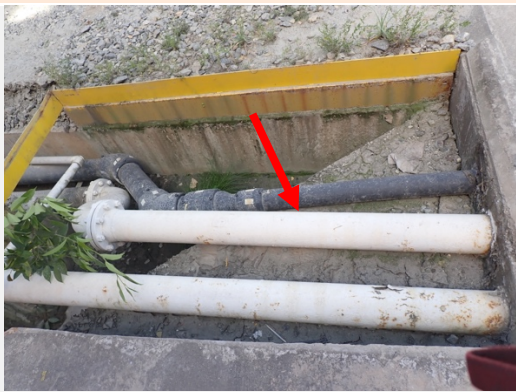
Photo: 15  
Comment: Berth 3. General view of the Fuel line at the penetration, between berth 2 and berth 3.
